**Docket No. 217 – Development and Management Plan Inspection**

Northeast Utilities Service Company Certificate of Environmental Compatibility and Public Need for the construction of a 345-kV electric transmission line and reconstruction of an existing 115-kV electric transmission line between Connecticut Light and Power Company’s Plumtree Substation in Bethel, through the towns of Redding, Weston, and Wilton, and to the Norwalk Substation in Norwalk, Connecticut.

**Date:** August 25, 2005

**Location:** 115 kV Underground Route

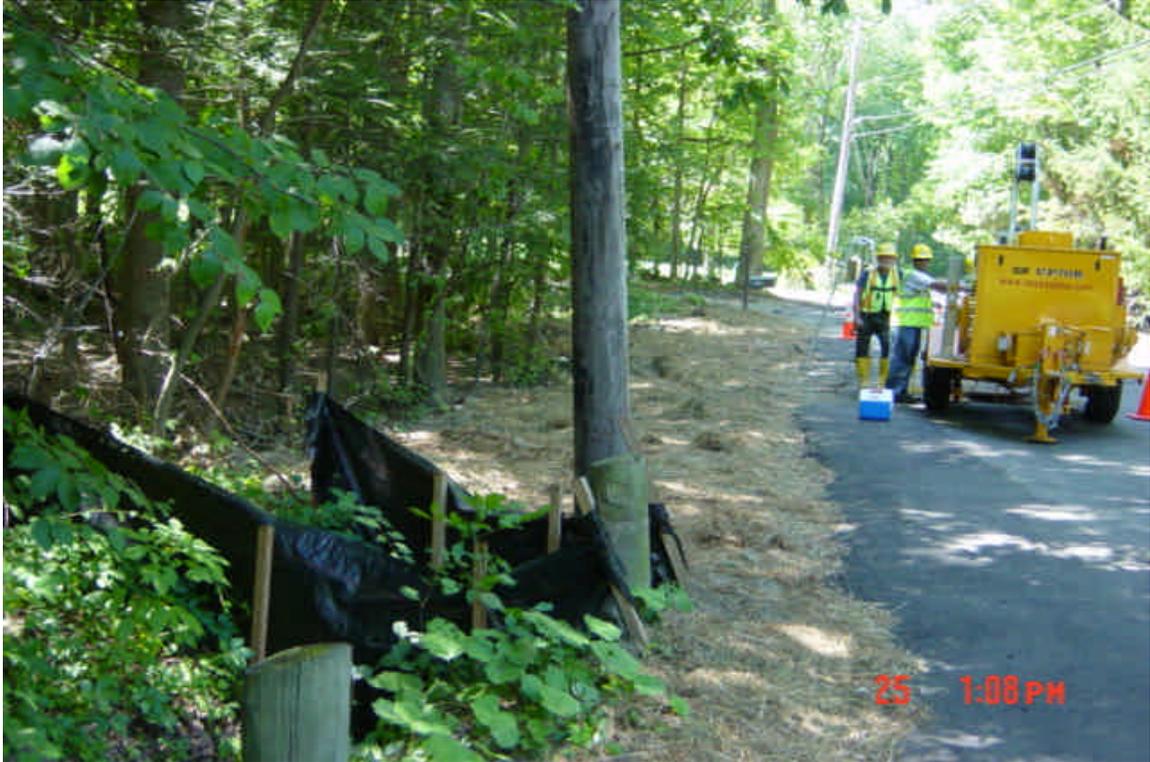
115 kV (Gallows Hill Road): Crews were beginning to work within the manholes in order to blow cables now that the infrastructure is in place in this roadway. 8/25/05

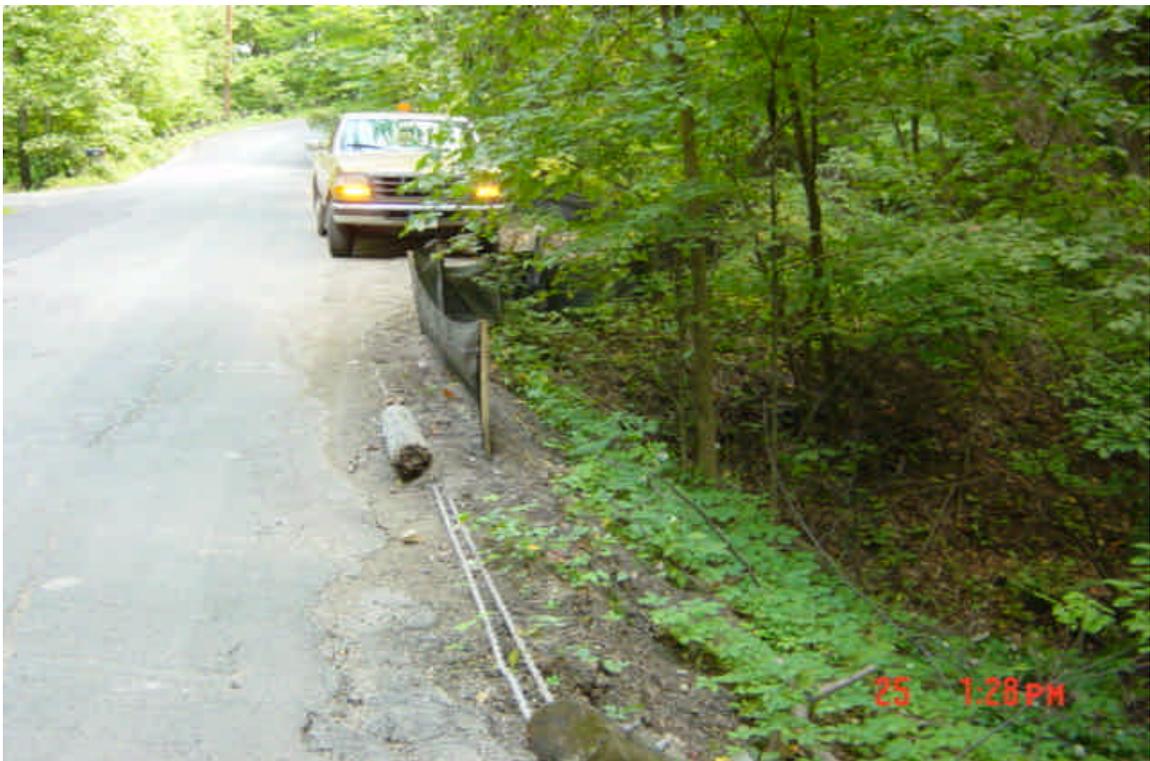
Additional Observations	<ul style="list-style-type: none"> <li>- A few posts and "guardrail" cable have been knocked over near #116 Gallows Hill. 8/19-</li> </ul>	<ul style="list-style-type: none"> <li>- The existing posts are fairly worn here but some repairs/replacements should be</li> </ul>

View of area near #116 where sedimentation from a pull off area may require a haybale near the end of the fence. Posts and guardrail cable were also knocked over and should be repaired 8/25/05

Areas of Inspection	Observation	Recommended Action
	8/25/05	made. 8/25/05

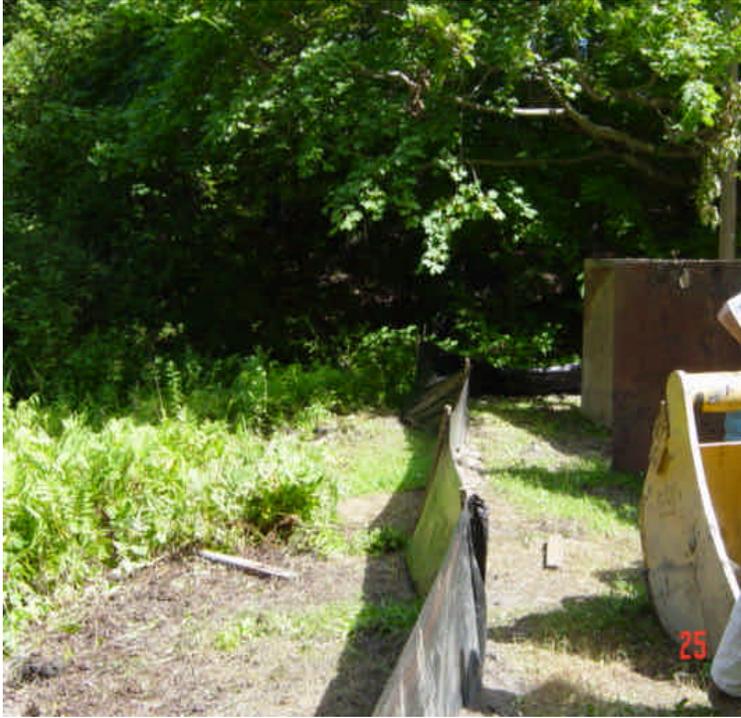
**115 kV (Rt. 58 near Putnam Park):** Photo on the left shows where the silt fence was pulled back from the wetland vegetation as recommended. Photo on the right shows where additional silt fence was added as recommended. 8/25/05

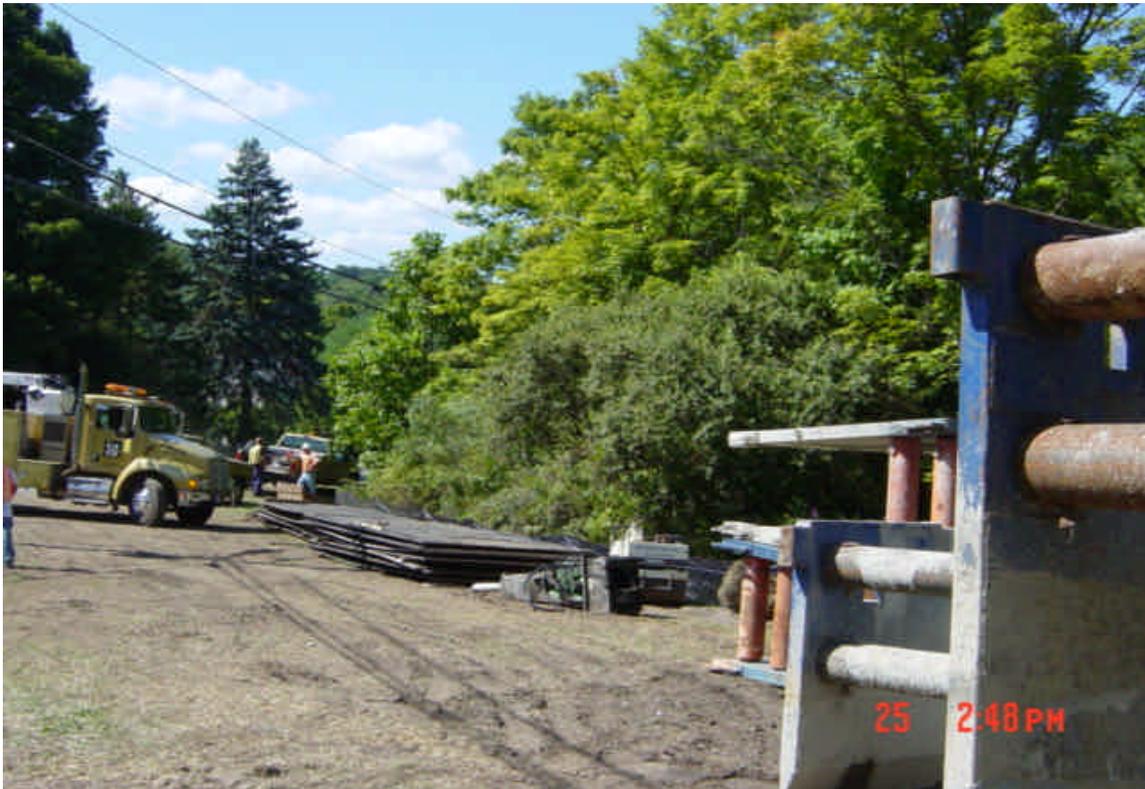
**115kV (Rt. 58):** A new staging area near the intersection of Rt. 58 and Sunset Hill Road was identified in this inspection and silt fence was installed. 8/25/05

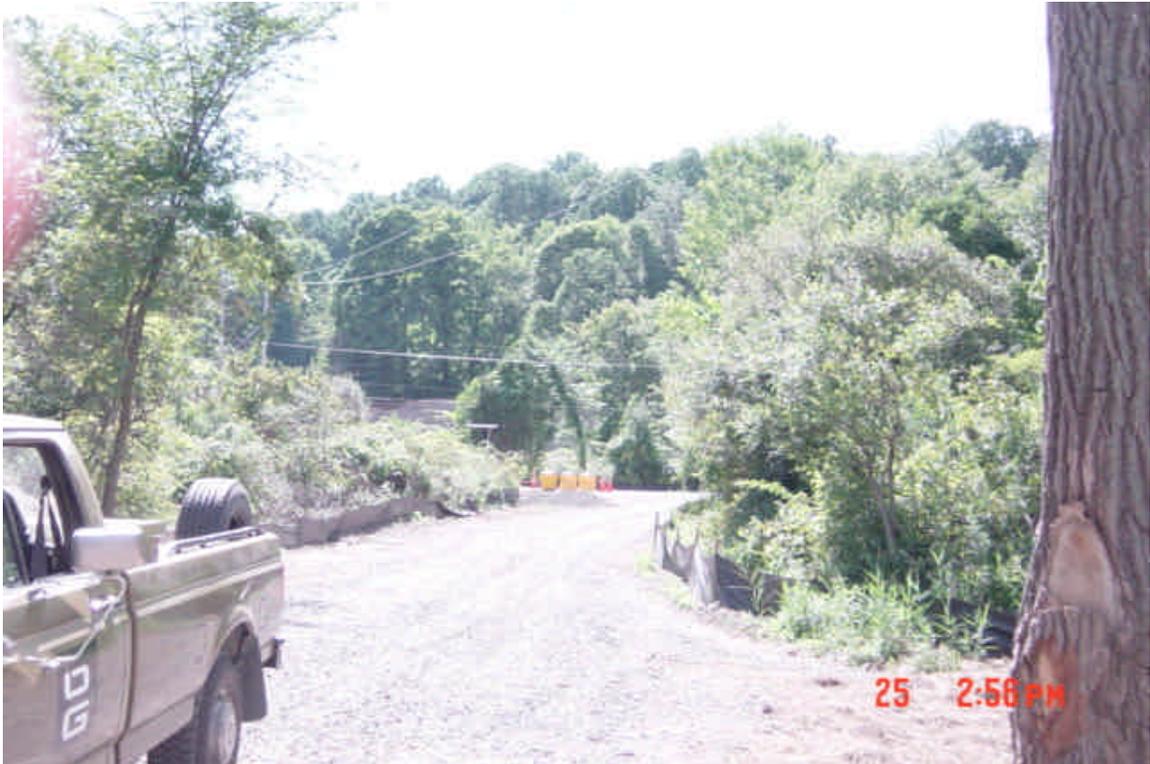
115kV (Route 58, near Hoyts Hill- Transition Pole): View of the access road which has been cleaned up and stabilized with stone. A few piles of materials remain. 8/25/05

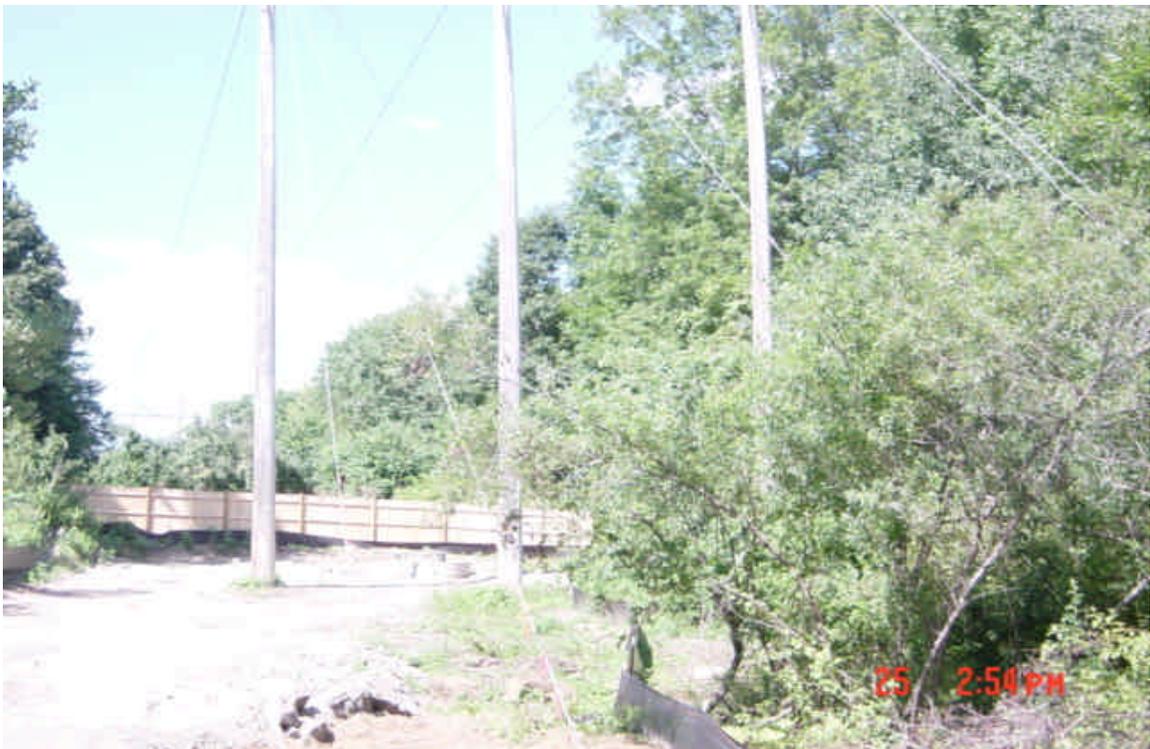
View of the caisson area. The area has been cleaned up for the most part. 8/25/05

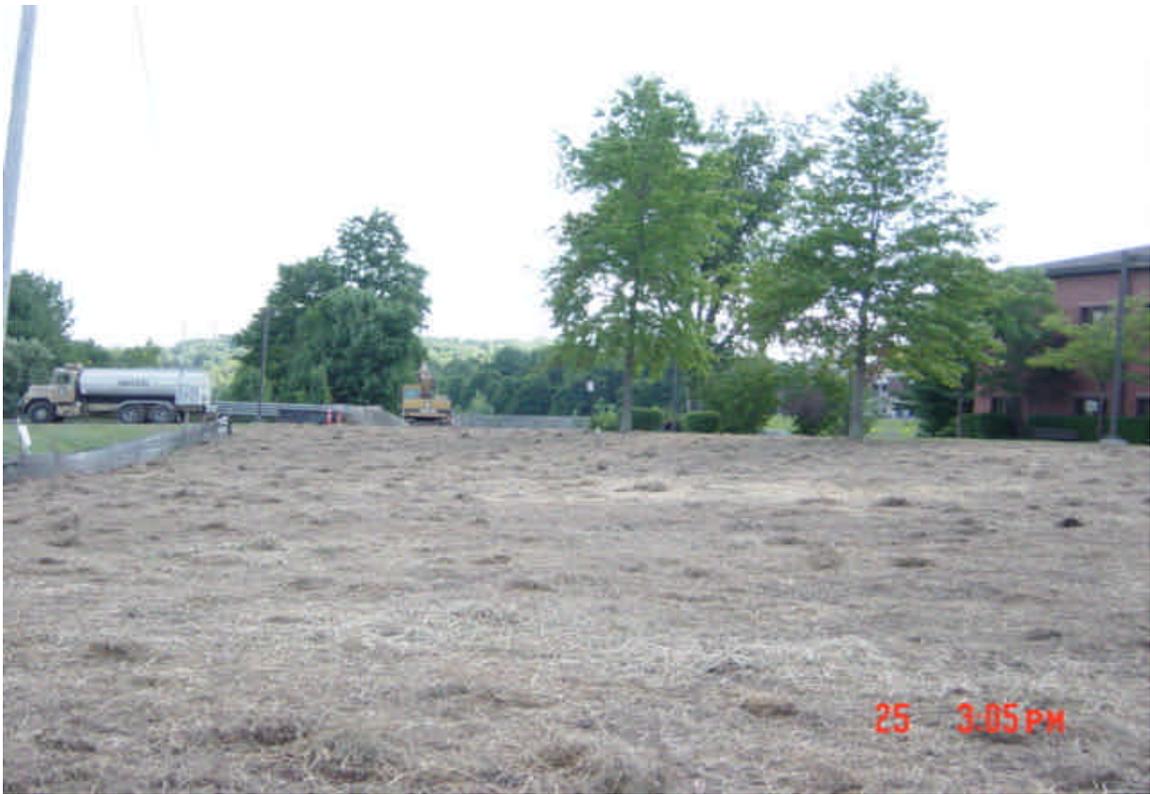
115 kV (Bethel Education Park): The area in front of the Bethel Middle School where the vault was installed has been restored and placed with mulch 8/25/05

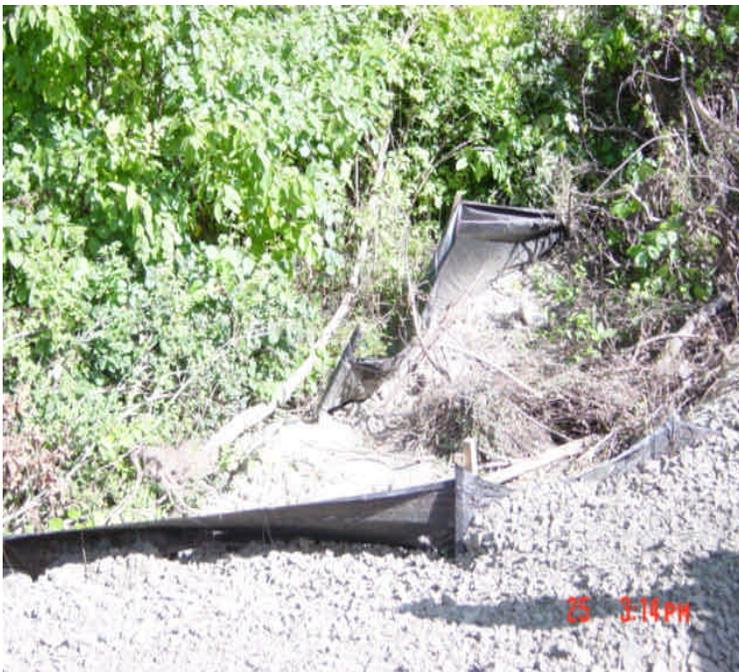
<p><b>Bethel Educational Park</b></p>	<p>- All disturbed areas within school lawns were restored and mulched and sidewalk work was complete. 8/25/05 - Restoration efforts were also ongoing along the ROW. 8/25/05  - The ROW near the southern caisson still had the sediment against the fence at the low spot within the brush and a small gap in the fence. 8/25/05  - A small spot in the fence near the soil stockpile at the edge of the ROW was close to being toppled 8/25/05</p>	<p>- Keep the controls in good repair until the ROW is revegetated. 8/19/05  - Crews were moving towards this area making repairs in the silt fence and they were notified. 8/25/05</p>

Photo on the left shows an area near the southern end of the ROW that needs some attention. Silt fence repairs were moving in that direction by Friday. The photo on the right shows the northern portion of the ROW which was also being restored Friday. 8/25/05
