Docket No. 217 – Development and Management Plan Inspection

Northeast Utilities Service Company Certificate of Environmental Compatibility and Public Need for the construction of a 345-kV electric transmission line and reconstruction of an existing 115-kV electric transmission line between Connecticut Light and Power Company's Plumtree Substation in Bethel, through the towns of Redding, Weston, and Wilton, and to the Norwalk Substation in Norwalk, Connecticut.

Date: March 2, 2006

Location: Overhead Line (Composite 345kV and 115kV Gallows Hill to Archers Lane) and (345kV H-Frame Hoyts Hill to Gallows Hill)

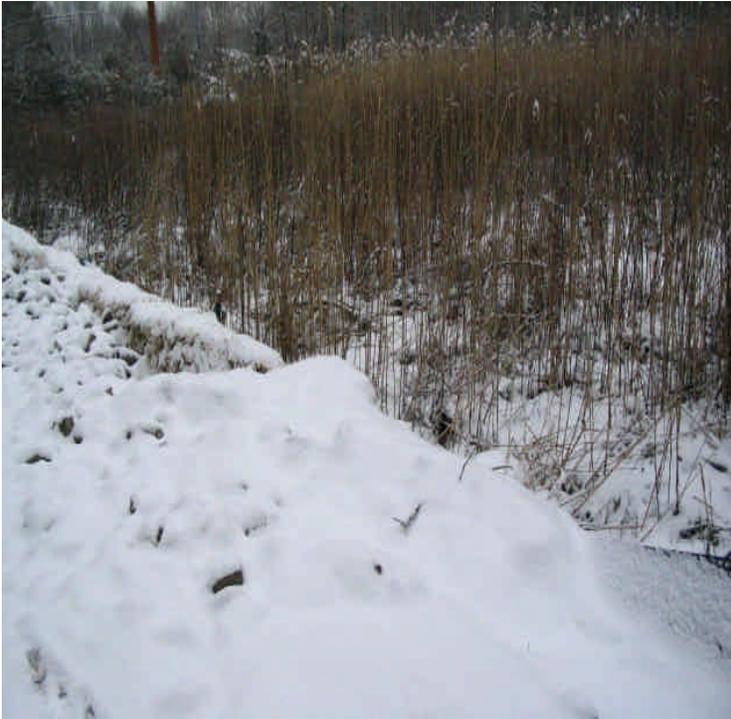
(Composite Section): Photo on the left shows a view of the 2nd crossing along the road from Archers Lane. Snow/sediment piles from the last storm still need to be removed. Photo on the right shows a spot where haybales were installed at the damaged silt fence at the 3rd crossing. 3/2/06

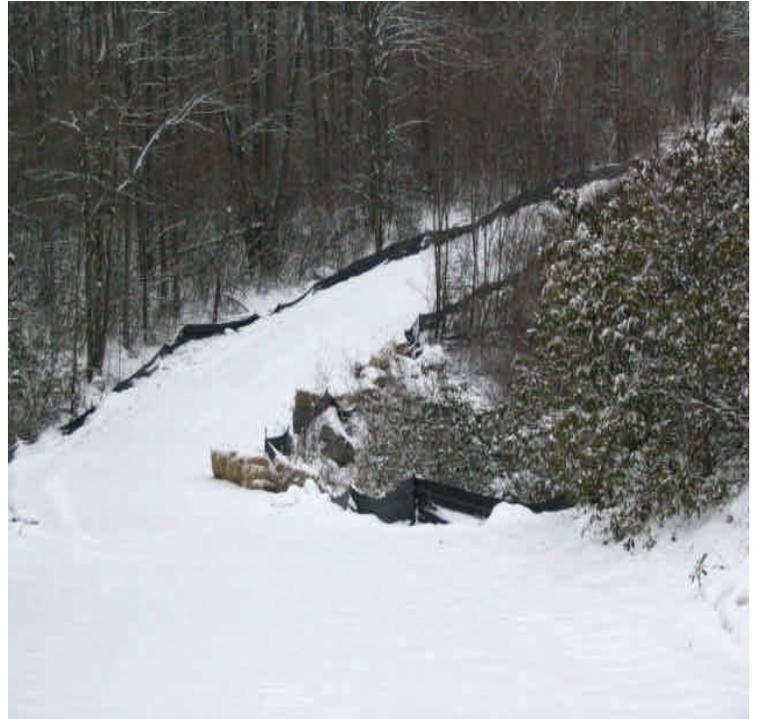
<p>Inland Wetland and Watercourse encroachment and mitigation</p> <p>Composite</p>	<p>-The D&M plan approved stone on geotextile fabric at the wetland crossings had worked well, but at three areas near Archers Lane, turbidity issues have been present. Run-off from the road, the drainage pipe, and snow plow issues had led to sedimentation. 1/4-3/2/06.</p> <p>- New deposits of sediment were noted in the wetlands beyond the controls at the 2nd and 3rd wetland crossings due to recent snow plowing and direct damage was noted to the wetland at the 3rd crossing as a</p>	<p>- As the access is considered temporary, the stone will be removed when final work ends so the wetlands can be restored. 1/26-3/2/06.</p> <p>- Issues remain from the recent plowing. The sediment has to be carefully pulled back from the wetland.</p> <p>- The damage to the 3rd wetland should be repaired as well 3/2/06.</p>

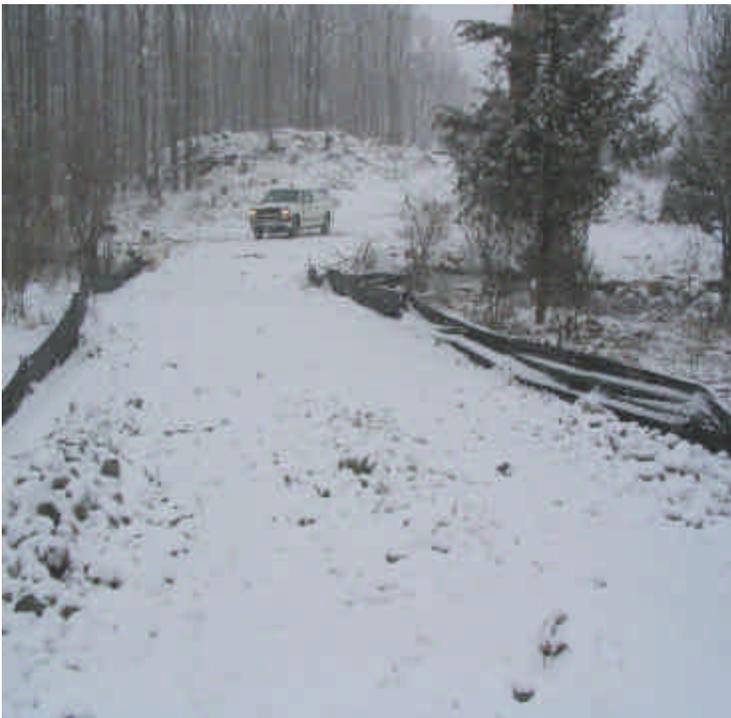
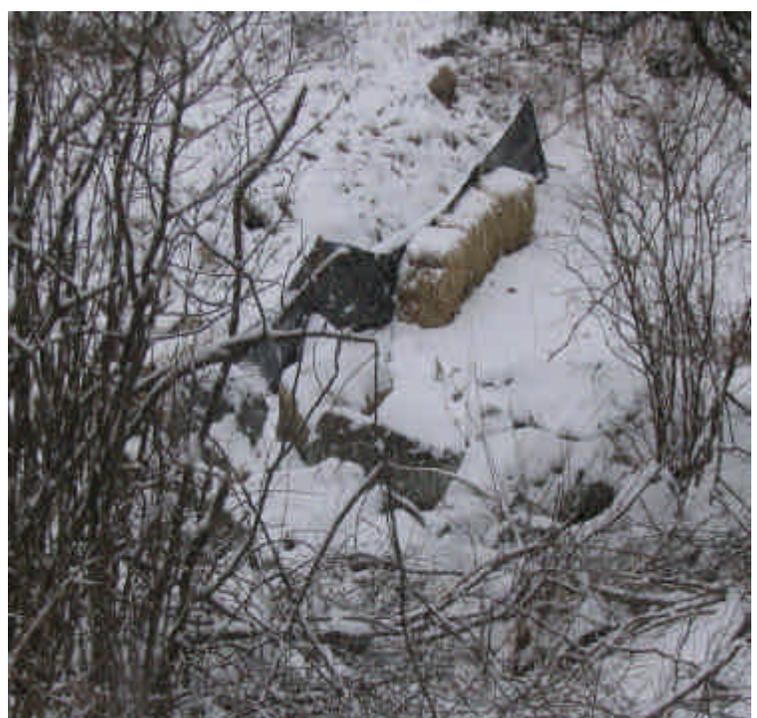
Photo on the left shows the wetland crossing near the 2nd structure within the Gallows Hill Section. Erosion controls have been repaired at the structure and along the access road. Photo on the left shows where soil had been pushed over the fence but controls were repaired. It should be confirmed that all soil has been removed from the wetland. 3/2/06

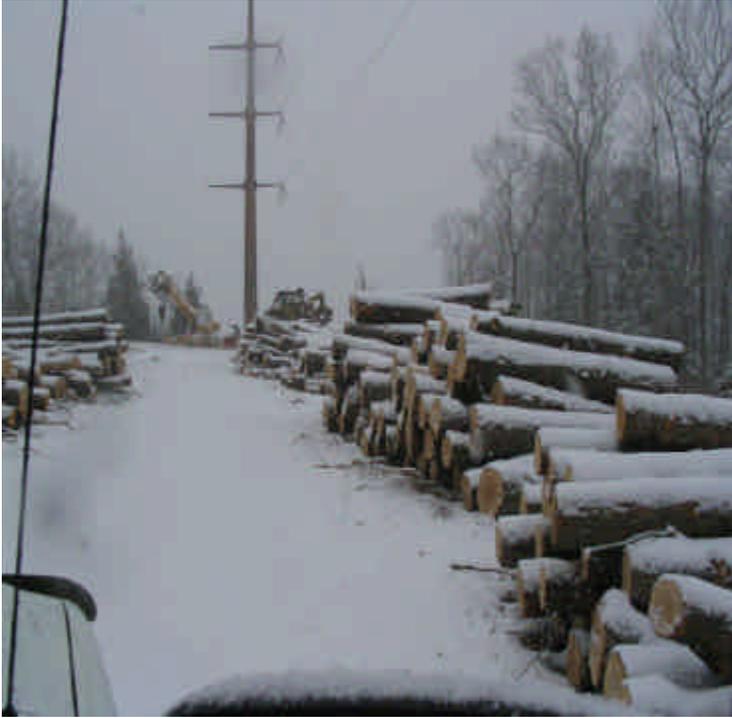
Areas of Inspection	Observation	Recommended Action
<p>Vegetative clearing limits (including trees to save or danger trees noted)</p>	<p>-Significant clearing was noted in the composite section near Gallows Hill Rd. This includes work in wetlands. Adjacent homeowners mentioned damage to mountain laurel and other shrubs and also noted machines in the wetland. 3/2/06.</p> <p>- A significant amount of chips were blown into the upland area off the cleared ROW. This could smother plants and reduce habitat. 2/22-3/2/06.</p> <p>- Significant clearing continues in the Chestnut Ridge Rd. to Hoyts Hill section. Chips were being spread on the ROW in this area. 2/16-3/2/06.</p> <p>- Efforts have been good to keep chips out of wetlands and placing them on the access road helps increase stability. 3/2/06.</p> <p>- Carefully remove any larger branches or brush strewn in streams and wetlands. This was noted in a number of locations. 2/9-3/2/06.</p> <p>-Clearing also continues near Costa Lane and John Todd Rd. 3/2/06</p>	<p>- Take care in retaining shrubs and use mats to access or skid out trees from wetlands. 2/22-3/2/06.</p> <p>- Chips need to remain on ROW or be removed. Chips currently off ROW should be removed. 2/22-3/2/06.</p> <p>-Keep clearing to what is necessary. The D&M plan states low growing shrubs can remain. 12/22-3/2/06. Makes efforts to retain shrubs. 2/22-3/2/06.</p> <p>- Chips spread on the ROW should not be to a depth of more than 3” by the time the growing season is about to begin. 1/4-3/2/06.</p> <p>- Efforts to retain shrubs were noted in some sections. Attempt to retain buffers, especially at streams and wetlands. 2/2-3/2/06.</p>

Photo on the left shows the ongoing clearing activities and piling of trees at Gallows Hill. (345kV H-Frame): Photo on the right shows pre-drilling for structure installation within the Costa Lane Section. 3/2/06.

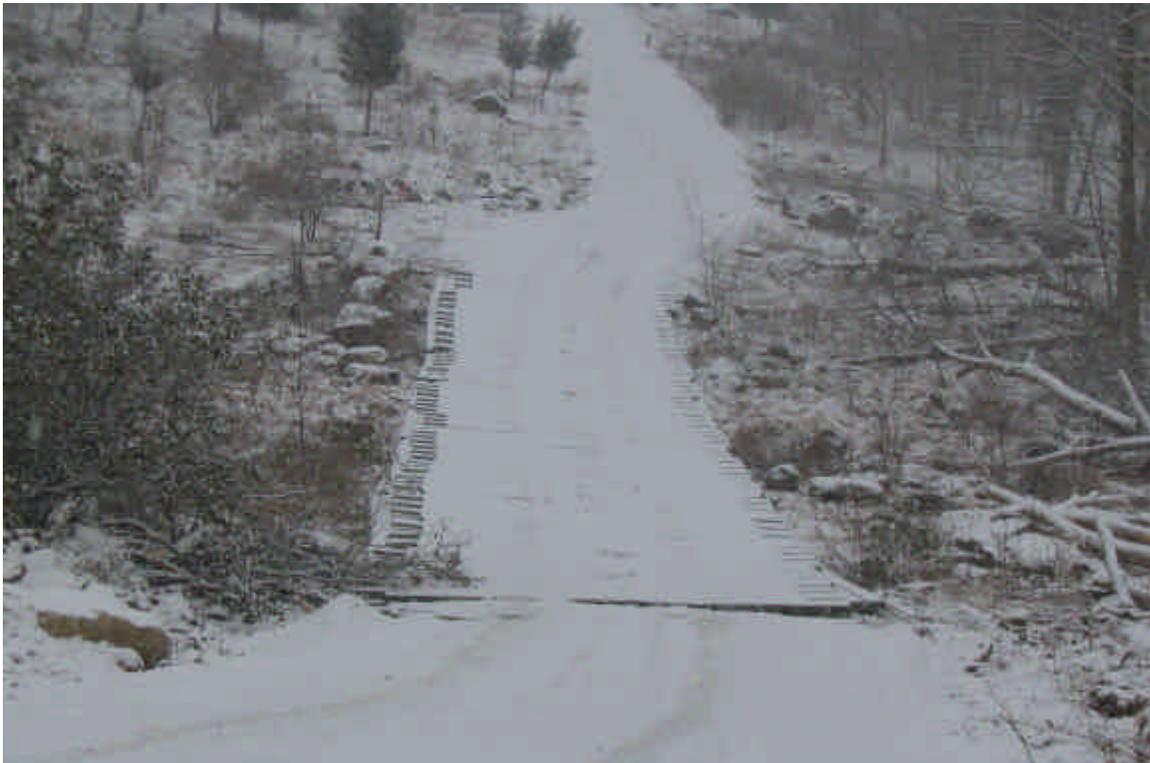
(345kV H-Frame): This photo shows the wetland crossing near structure #28 along Costa Lane. Brush should be removed from the wetland and silt fence installed at the corners of the crossing, upon approach. 3/2/06

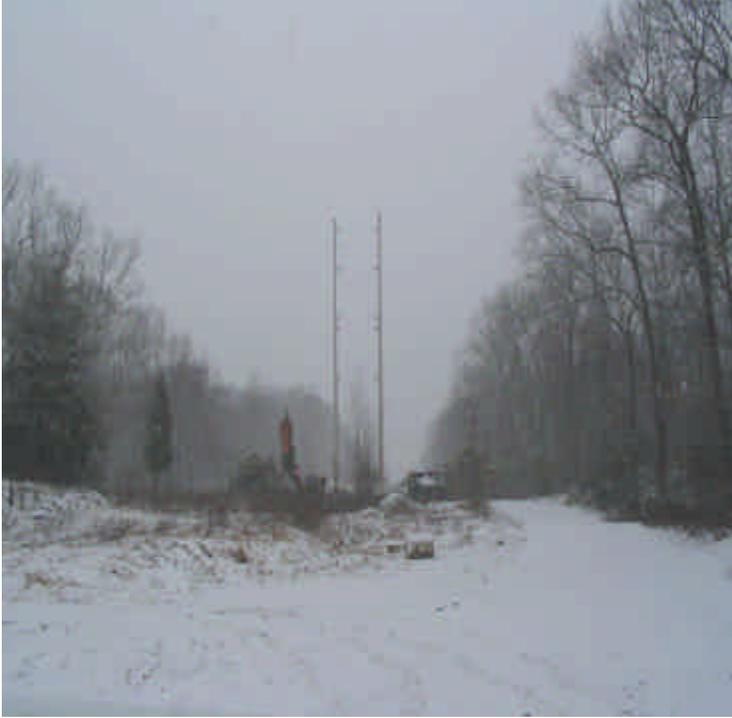
Photo on the left shows pre-drilling for structure installation at pole #22, off John Todd Way. Photo on the right shows a view of the clearing taking place at the adjacent structure. 3/2/06.

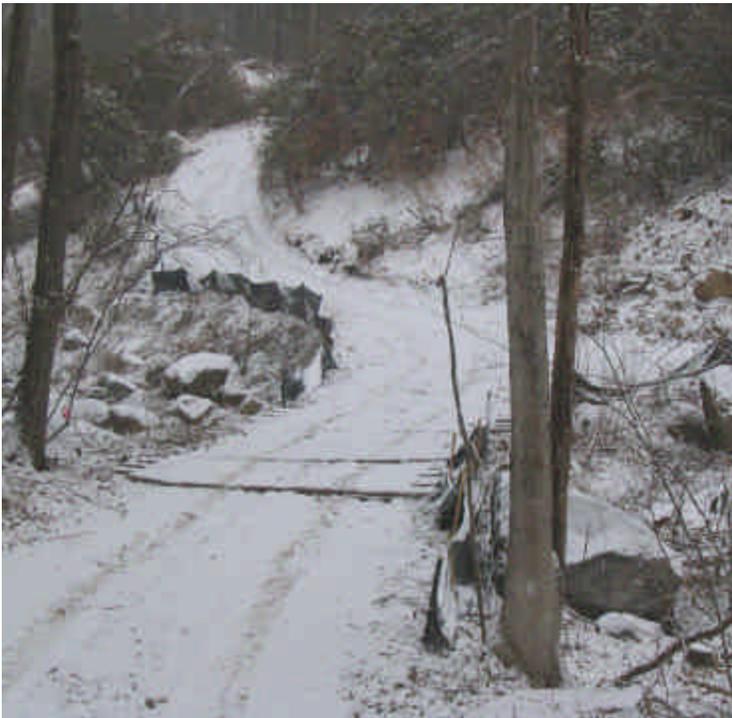
Areas of Inspection	Observation	Recommended Action
Costa Lane	<p>been placed. Silt fence was also installed at the corners of the crossing between #17-18 3/2/06.</p> <p>- Conditions had been muddy on the access road near proposed pole #19 beyond the original mat at the crossing. Two additional mats have been installed to increase stability here as recommended. 3/2/06.</p> <p>-Silt fence was also installed at structure #19 now that foundation work is beginning here. 2/22-3/2/06.</p> <p>- Sediment had run-off the access road between poles #19 and 21 into some wetland pockets. Silt fence has been installed here to prevent further sedimentation as recommended. 3/2/06.</p> <p>-Mats have been installed at the wetland crossing in the vicinity of pole #28. 3/2/06.</p>	<p>3/2/06.</p> <p>- Continue to monitor this crossing for increasingly muddy conditions on the mats. 3/2/06.</p> <p>-Continue to maintain fence as necessary due to the proximity of the wetlands. 2/22-3/2/06.</p> <p>-Continue to maintain fence as necessary. 3/2/06.</p> <p>- Erosion controls should be installed at the corners of the mats at the approach. Continue to monitor the crossing for increasing muddy conditions. 3/2/06.</p>

Photo on the left shows a view of the wetland crossing at structure #19 within the Bethel Reservoir section. Additional mats have been placed in this area. Photo on the right shows a view of the silt fence installed between structure #19 and #21 as recommended. 3/2/06.

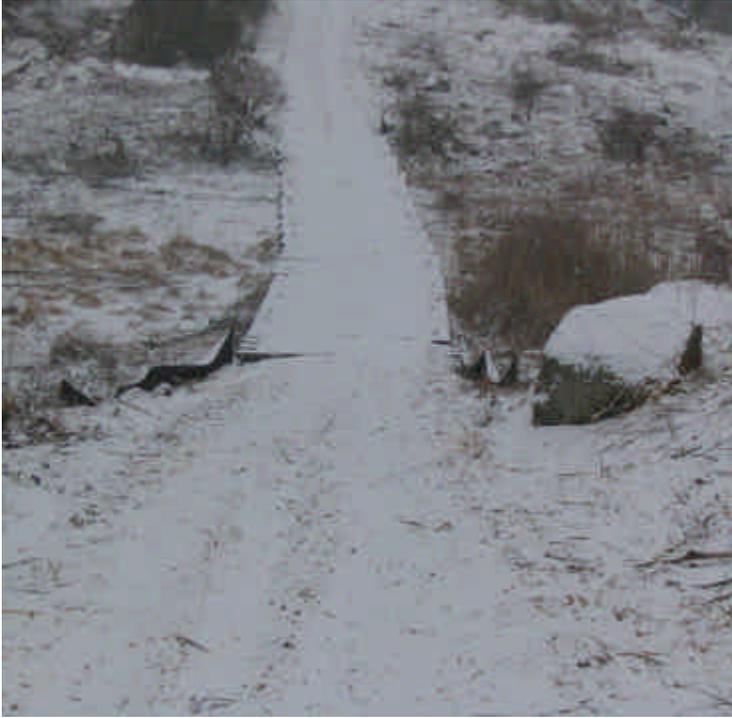
Photo on the left shows a view along the access road in the Bethel Reservoir section with erosion controls in place at the approach as recommended. Photo on the right shows pole placed for installation along the Chestnut Ridge section. 3/2/06.

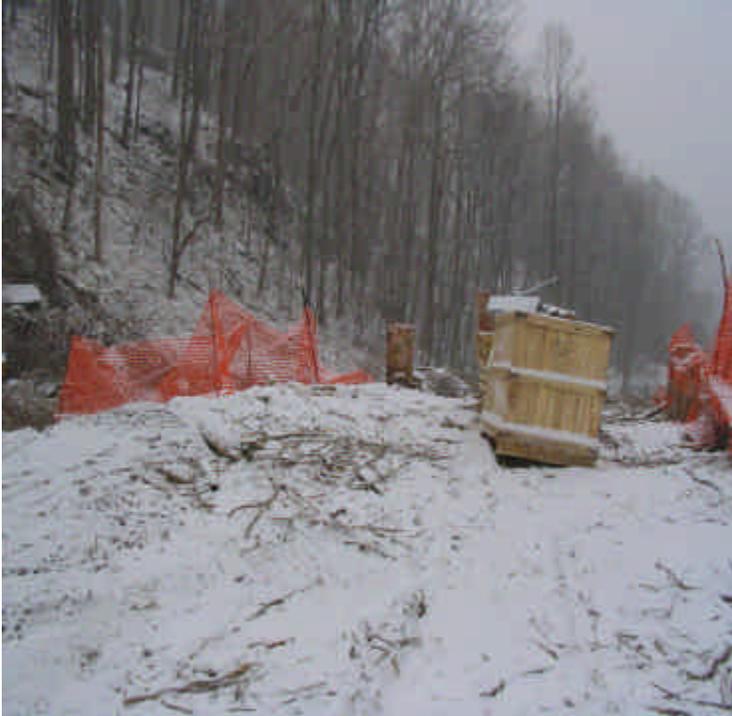
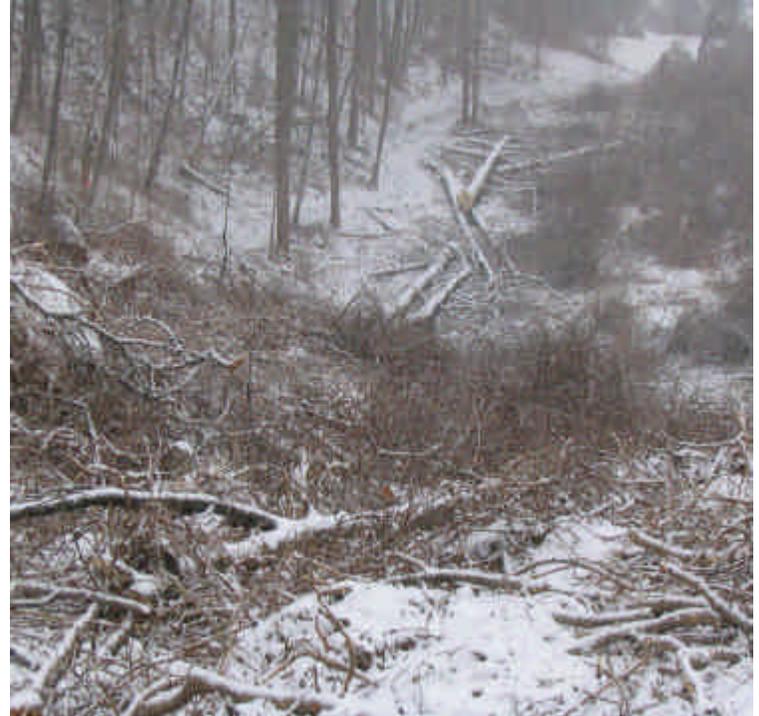
Both photos show ongoing activities at the Chestnut Ridge Road section. The photo on the left shows excavation for poles and the photo on the right shows ongoing clearing activities. 3/2/06.
