**Docket No. 217 – Development and Management Plan Inspection**

Northeast Utilities Service Company Certificate of Environmental Compatibility and Public Need for the construction of a 345-kV electric transmission line and reconstruction of an existing 115-kV electric transmission line between Connecticut Light and Power Company's Plumtree Substation in Bethel, through the towns of Redding, Weston, and Wilton, and to the Norwalk Substation in Norwalk, Connecticut.

**Date:** July 28, 2005

**Location:** Transition Stations (Hoyts Hill, Archer's Lane)

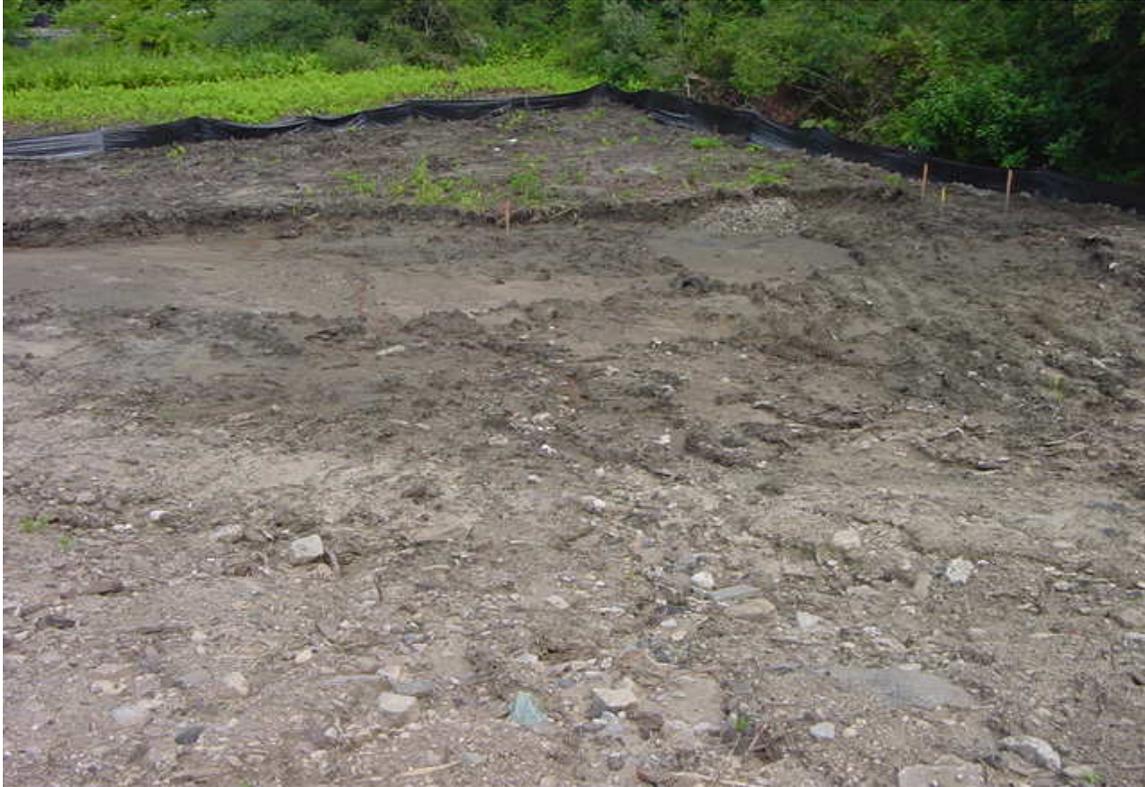
Hoyts Hill Transition Station: View of the cleared area within the ROW for the construction of the station. Repairs were made along the side row of silt fence. (7/28/05)

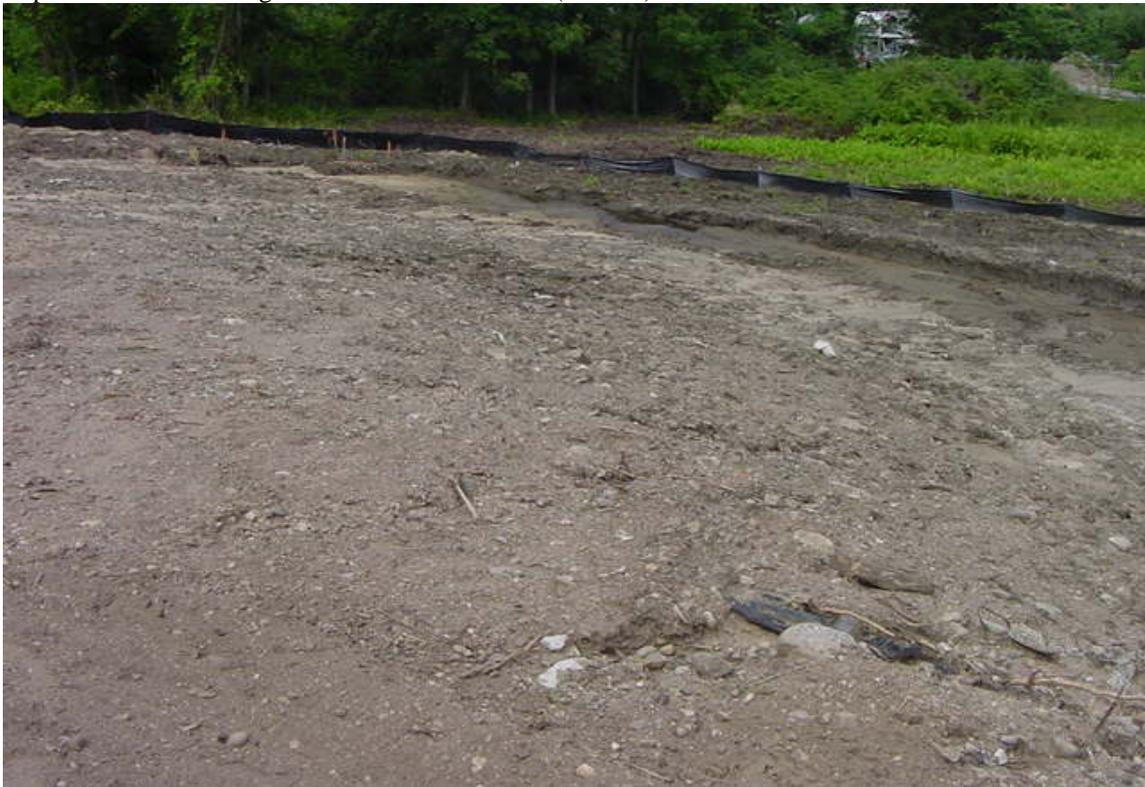
Additional view of the area. A second row of silt fence will be added along the east row of fence to help control sedimentation and repairs will be made early next week. (7/28/05)

Areas of Inspection	Observation	Recommended Action
<p>Erosion and Sediment Controls (includes inspection within 24 hours of a storm event)</p>	<p><b>-Hoyts Hill:</b> BSC walked the site with a representative from Powers engineering to discuss repairs directly. The holes and worn spots in the eastern row of silt fence will be repaired in time for the next inspection. 7/28/05.</p> <p>-A second row of silt fence will be installed along the eastern perimeter fence to help control the sedimentation that runs down the slope to this spot. 7/28/05</p> <p>- Repairs will also be made to the southern side of the fence and a small area of sand/soil noted on the other side of the fence will be encompassed within the fence. 7/28/05</p>	<p>- The worn areas of the fence will be replaced and the bottom of the fence will be buried 4-6 inches into the soil. This is scheduled to occur by the next inspection 7/28/05</p> <p>- The fence will also be reinforced by placing an additional line of fence about 15 feet upgradient. This will help slow sedimentation and run-off 7/28/05</p> <p>- The fence will be repaired and extended to encompass the small area of bare soil beyond it. 7/28/05</p>

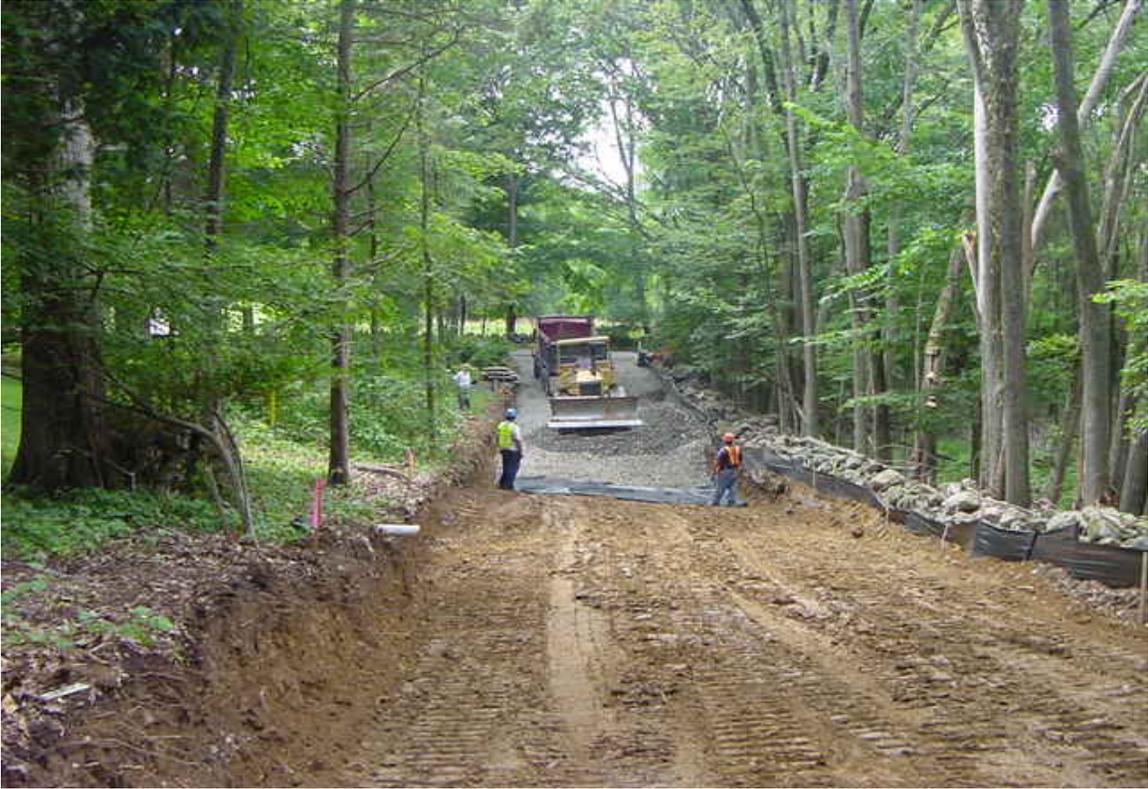
Archer's Lane Transition Station: Stone is being added to the entrance of the access path off Diamond Hill Road. (7/28/05)

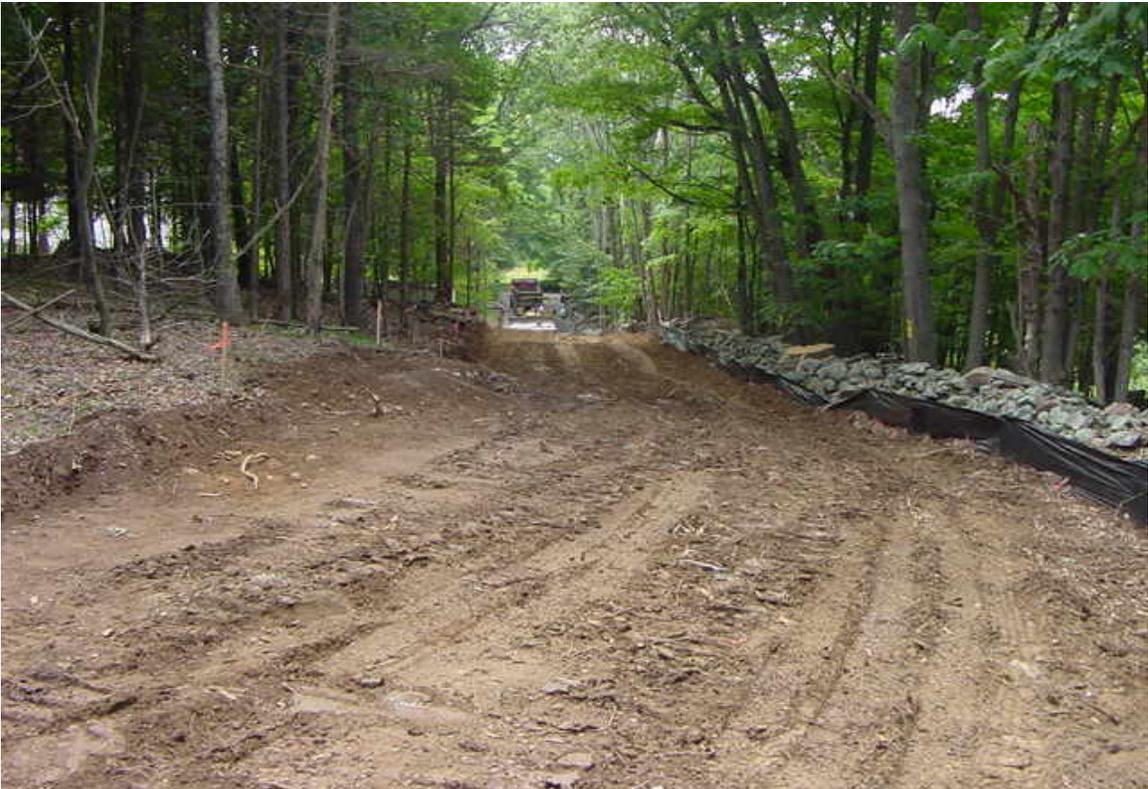
Additional view of the access road and installed silt fence. There were no noticeable repairs to be made. (7/28/05)
