NEPA ENVIRONMENTAL REVIEW REPORT

**Community Development Block Grant – Disaster Recovery
Owner Occupied Rehabilitation and Rebuilding Program**

**Site ID No. 1390
19 Young Dixon Way
Stamford, Connecticut**

May 2014

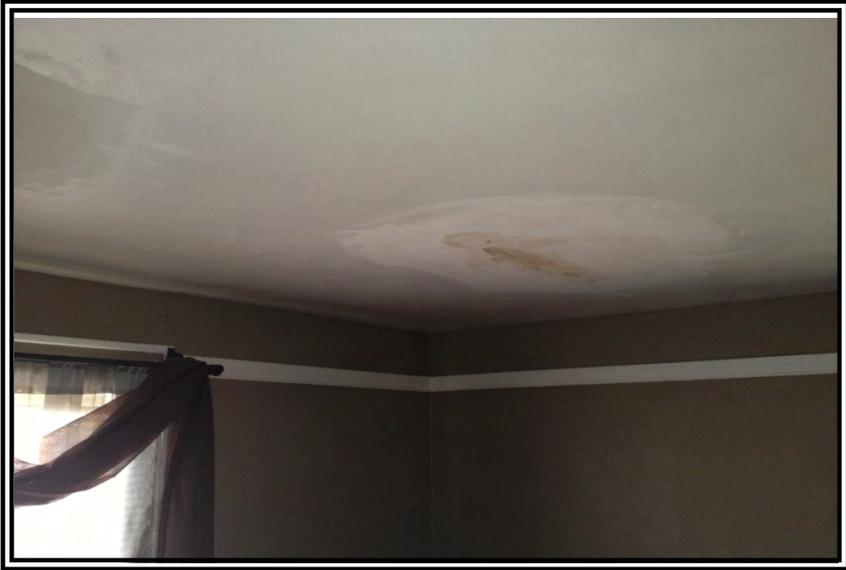
The proposed work plan for the 19 Young Dixon Way property includes repairing siding on northeast corner of house, replacing roof shingles, and abating mold and water damage resulting from the leaking roof. As such, the work zone as described by Merritt consists of the roof and northeastern exterior side of the house, and the interior ceiling of a first floor bedroom.

Water staining in first floor bedroom ceiling

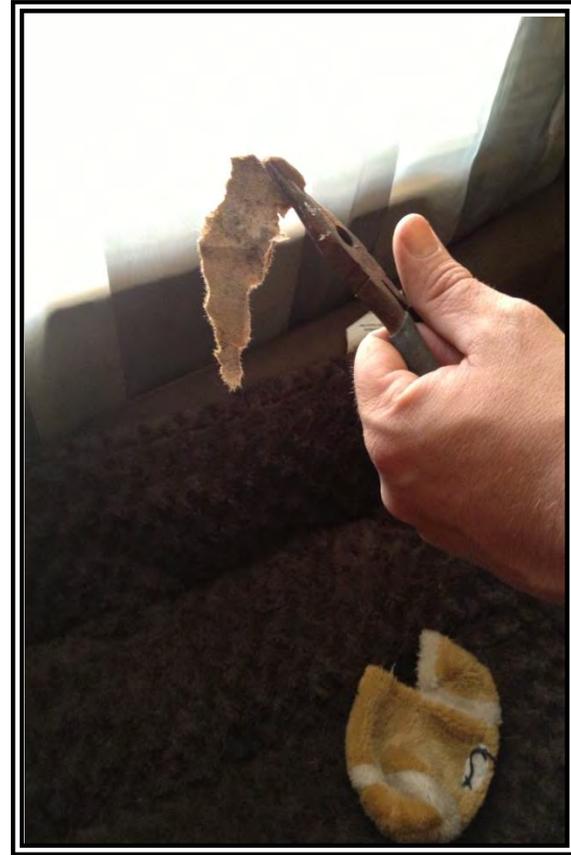
Triton completed a visual mold inspection of the work area on April 14, 2014. Mold was observed on the brown paper backing of the insulation within the work area. A photograph of the apparent mold is provided in Appendix B. Although access to the attic was not available to complete a visual inspection, it is likely that mold is present on other surfaces within attic spaces.

Black mold on attic insulation paper

Mold was observed on brown paper backing of the insulation and may be present in areas that could not be observed during the inspection (i.e. attic). To protect occupant and worker health, the mold within the work zone must be abated. Any porous materials containing visible mold that are encountered during the renovation should be removed in accordance local, state, and federal regulations including, but not limited to, with the guidelines put forward in the most recent version of the *Institute for Inspection, Cleaning, and Restoration Certificate (IICRC) Standard and Reference Guide for Mold Remediation* as well as the *Connecticut Guidelines for Mold Abatement Contractors*. The abatement contractor must provide credentials/adequate qualification documentation and a work plan for abatement work with its bid for review by Merritt and Triton. Clearance testing requirements will be determined by Merritt, the homeowner, and the State of Connecticut.

1. Mold – Mold was identified on the brown paper backing of the insulation within the work area. To protect occupant and worker health, the mold must be abated. Although access to the attic was not available to complete a visual inspection, it is likely that mold is present on other surfaces within attic spaces. Additional mold impacts surfaces may be encountered during renovation in spaces that were inaccessible or not apparent during the inspection. As such, Triton recommends that a competent person be present during the renovation work who is capable of identifying potential additional suspect materials. General precautions should be taken during the renovation process to avoid the potential spread of mold spores and to mitigate health and safety concerns.
