STRUCTURE NO. 05588

ROUTE 74
over
HOCKANUM RIVER
VERNON

Routine Inspection
on
5/21/2010

Bridge Inspection Report BRI-18

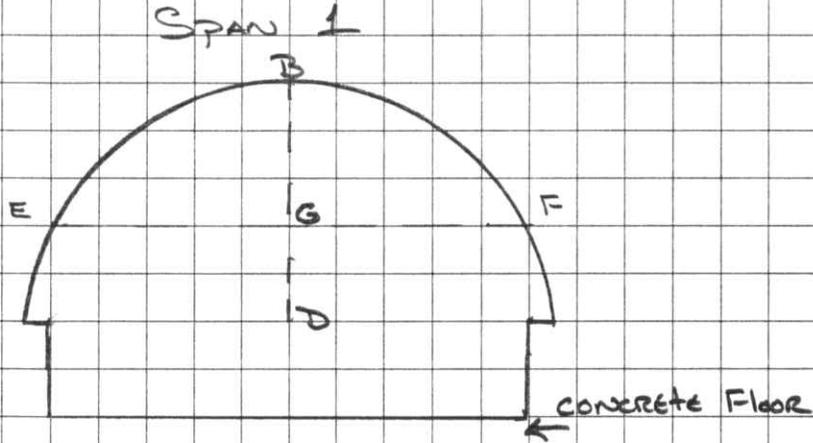
Bridge 5588 Route 74 over Hockanum River, Waterbury (N.T.S)

DATE	North End	Center	South End
5-27-08	E-F 122" B-G 25"	E-F 122" B-G 25"	E-F 122" B-G 25"
5/21/2010	E-F 122" B-G 25"	E-F 122" B-G 25"	E-F 122" B-G 25"

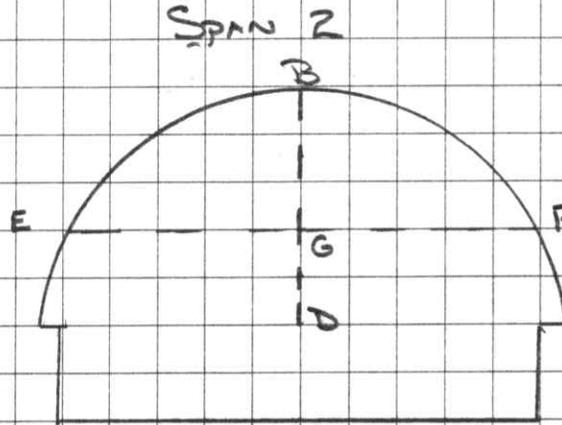
Bridge 5588 Route 74 over Hockanum River, Veenow (N.T.S)

Date	North End		Center		South End	
5-27-08	E-F	122"	E-F	122"	E-F	121"
	B-G	24 1/2"	B-G	24 1/2"	B-G	24 3/4"
5/21/2010	E-F	122"	E-F	122"	E-F	121"
	B-G	24 1/2" NC	B-G	24 1/2" NC	B-G	24 3/4" NC

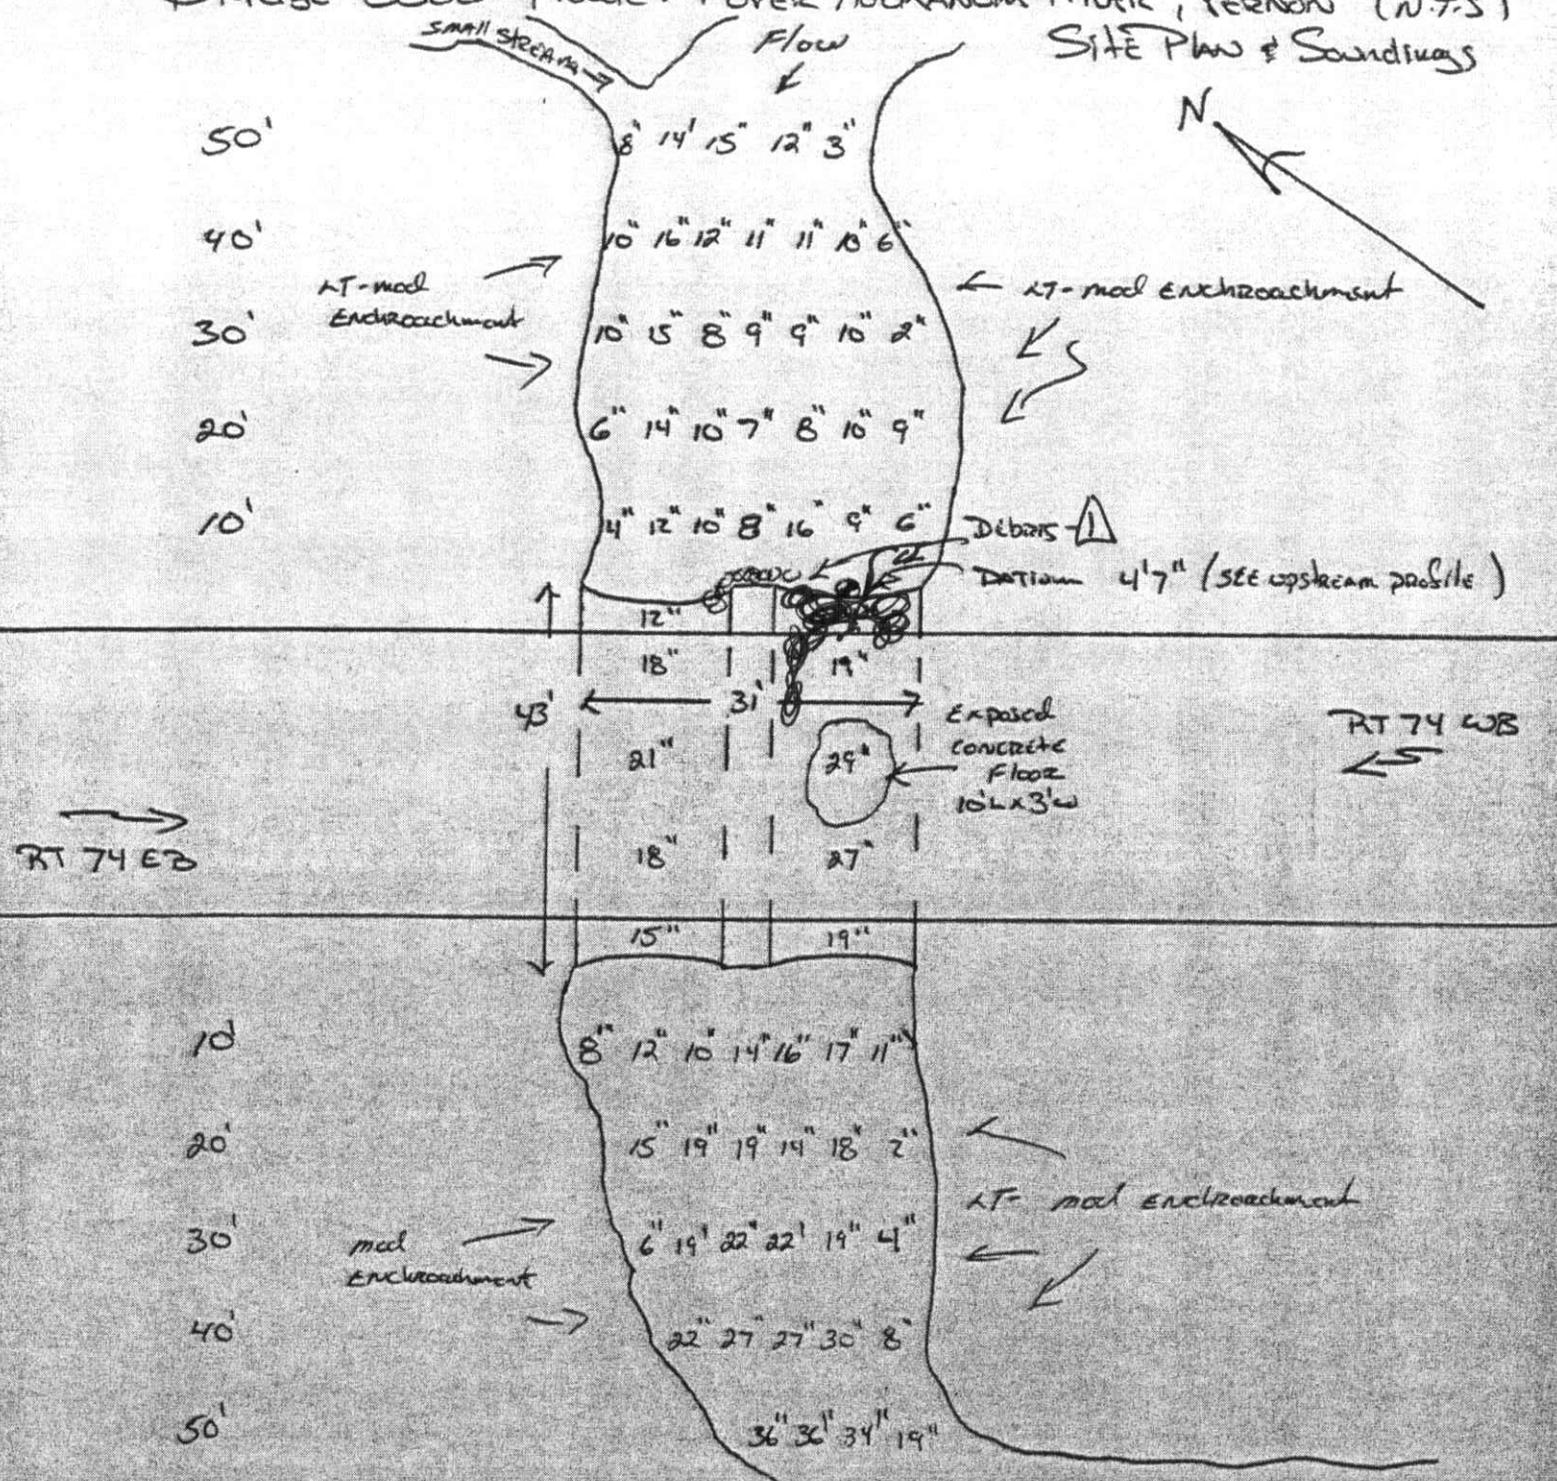
BRIDGE 5588 ROUTE 74 OVER HOCKANUM RIVER, VERNON (N.T.S.)
SITE PLAN & SOUNDINGS

CHANNEL SCOUR:	8	THE CHANNEL SHOWS A CONSTANT WATER DEPTH OF 12 TO 14 INCHES ALONG THE INLET. THERE APPEARS TO BE A FAIR AMOUNT OF PAST ACCUMULATED SILTATION, ALONG THE INLET. THE WATER DEPTH ALONG THE CHANNEL OUTLET, A SHORT DISTANCE FROM THE STRUCTURE, GOES TO ABOUT 3 FEET.
EMBANKMENT EROSION:	6	ALL EMBANKMENTS SHOW LIGHT, TO MODERATE ENCROACHMENT, THRU -OUT.
DEBRIS:	6	THERE IS A SINGLE TREE BRANCH ACROSS THE SOUTHERLY OUTLET, ABOUT 10 FEET FROM THE STRUCTURE. THERE IS STILL SOME LIGHT TIMBER DEBRIS LODGED ALONG THE OUTLET BANKS.
VEGETATION:	6	THERE IS HEAVY VEGETATION GROWTH ALONG ALL EMBANKMENTS.
CHANNEL CHANGE:	6	THE CHANNEL SHOWS A SWAMP TYPE ATMOSPHERE ALONG THE INLET. THE CHANNEL HAS PAST NARROWED ALONG THE OUTLET, DUE TO PAST EMBANKMENT ENCROACHMENT.
FENDER SYSTEM:	N	-
SPUR, DIKES & JETTIES:	N	-
RIP RAP:	N	RIP-RAP IS NOT NOTED ALONG THE BANKS OF THIS CHANNEL.

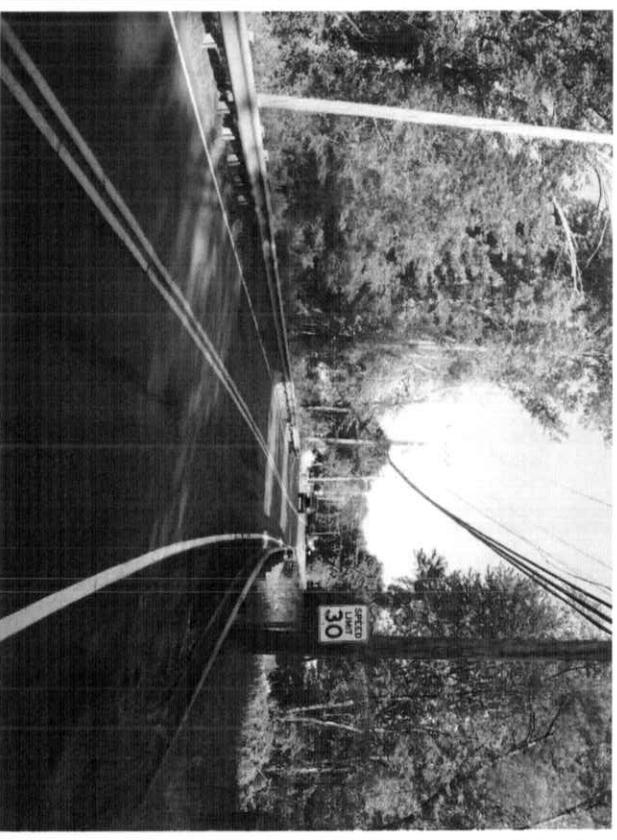
Photo # : LOOKING WEST OVER BRIDGE.

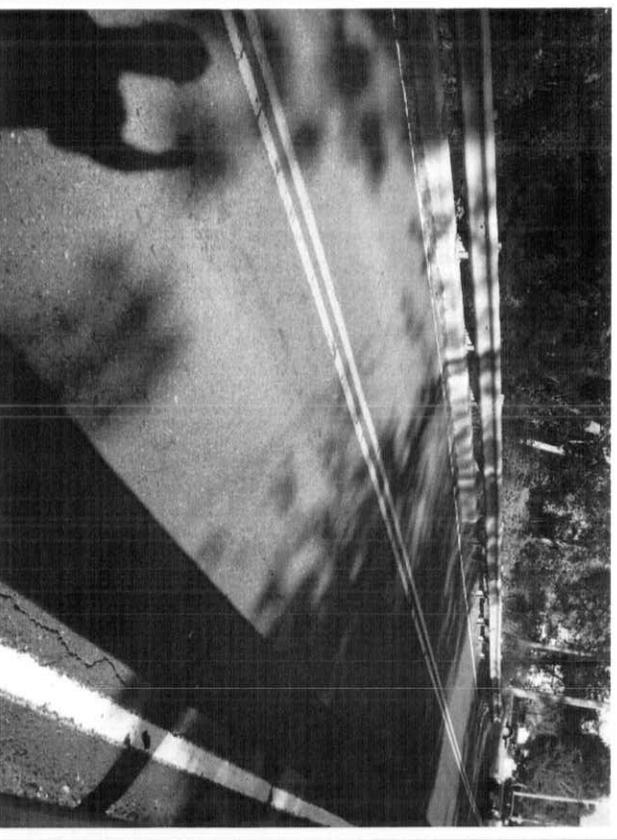
OVERLAY:	6	THE BITUMINOUS SURFACE, OVER ABOUT TWO FEET OF BALLAST MATERIALS, OVER THE CORRUGATED METAL PIPES ARCHS, APPEARS TO HAVE BEEN RESURFACED, SINCE THE 2002 INSPECTION DATE. THE SURFACE SHOWS LONGITUDINAL PAVING JOINT LINES, LONGITUDINAL, TRANSVERSE, MULTIPLE, AND RANDOM CRACKING, SOME ARE OPEN UP TO 1/2 INCH, LIGHT BITUMINOUS SEGREGATION, AND MINIMAL TIRE WEAR.THERE WAS AN AREA OF EROSION TO THE ROADWAY EDGE, ALONG THE NORTHERLY ELEVATION, OVER THE WESTERLY PIPE ARCH, WHICH MEASURED 13 LINEAR FEET LONG, WAS UP TO 3 FEET WIDE, AND WAS UP TO 3 FEET DEEP, WHICH WAS UNDERMINING THE SHOULDER EDGE UP TO 12 INCHES. LONGITUDINAL SURFACE BREAKAGE WAS NOTED WITHIN THE UNDERMINED SHOULDER. THE AREA OF EROSION WAS BETWEEN THE SHOULDER EDGE, AND THE CONCRETE MITERED SECTION OVER THE WESTERLY PIPE. THIS AREA HAS BEEN REPAIRED WITH STONE AND BITUMINOUS CONCRETE SINCE THE 2006 INSPECTION DATE.
DECK-STR. CONDITION:	N	-

Photo # : VIEW OF WEARING SURFACE.

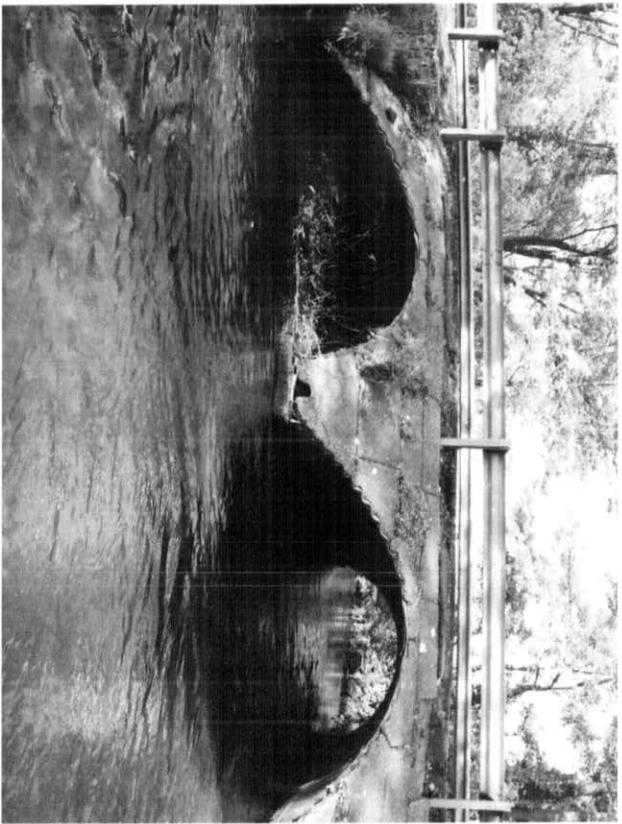
Photo # : NORTH ELEVATION.(UPSTREAM)

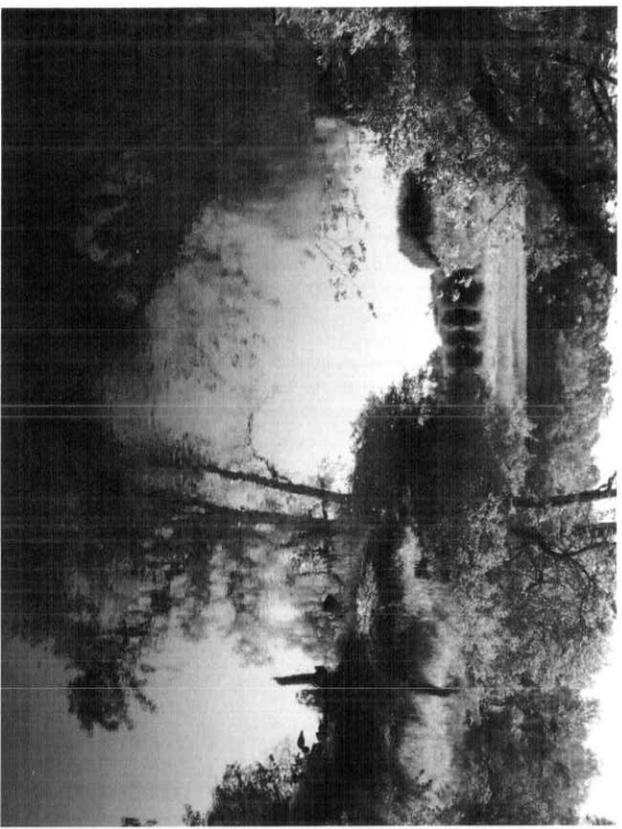
Photo # : LOOKING UPSTREAM.

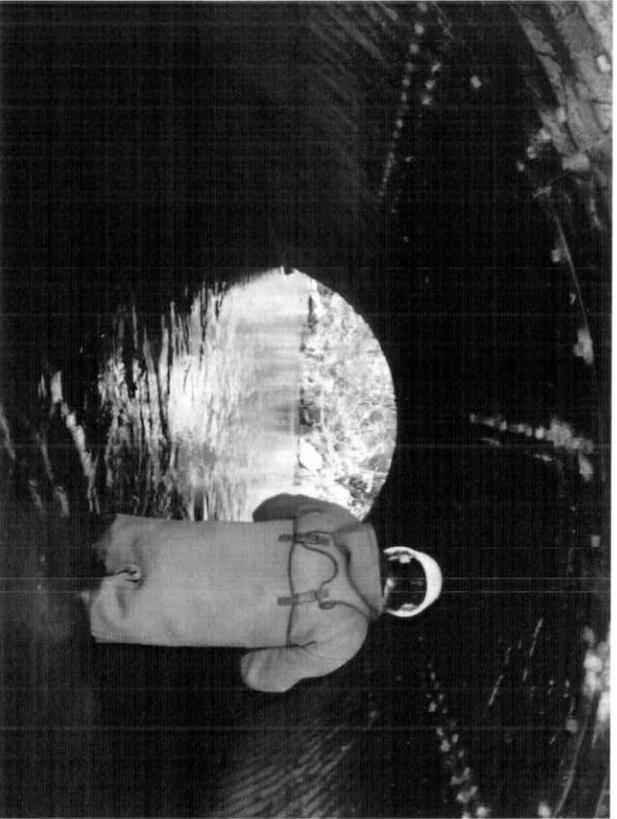
Photo # : LOOKING THRU WEST PIPE.

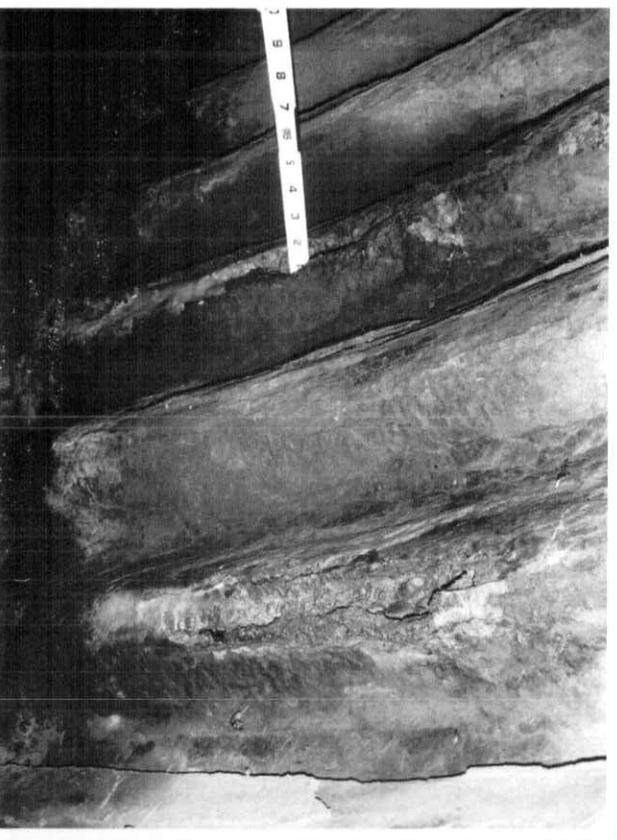
OVERLAY. EACH PIPE ARCH RESTS UPON A CONCRETE STEM, WITH A CONCRETE FLOOR. A MITERED CONCRETE PAVEMENT, IS USED ALONG EACH ELEVATION OF THE STRUCTURE, FOR BANK RETENTION.
CONCRETE:	5	THIS STRUCTURE SHOWS A CONCRETE FLOOR, WITH CONCRETE STEMS. IT IS ASSUMED ALL WERE CAST IN PLACE IN A MONOLITHIC FASHION. AT THE TIME OF INSPECTION, ONLY THE UPPER STEMS, AND THEIR CAPS WERE EXPOSED. ALL STEMS SHOW MODERATE SCALE, WITH POCKETS OF SEVERE SCALING TO THE STEM CAPS. THE FLOORS WHERE NOT COVERED WITH DEBRIS CANNOT BE REPORTED ON, DUE TO MURKEY WATER.
STEEL:	4	BOTH PIPE ARCHES ARE IN FAIR CONDITION, WITH A GOOD SYMMETRICAL APPEARANCE OF THE TOP ARC. THE BOLT LINES ARE STRAIT, WITH THE JOINTS SHOWING NO CUSPING, OR LEAKAGE INFILTRATION. AREAS OF THE ASPHALTIC COATING HAVE PAST WORN AWAY, UP TO 3 FEET HIGH, AND LIGHT TO HEAVY RUSTING, WITH LIGHT TO MODERATE LAMINAR SHEETS, AND RANDOM PERF HOLES, ARE NOTED ALONG THE WATERLINE, AT THE STEM JUNCTIONS. AT LEAST 12 CELL RIBS WITHIN THE WESTERLY CELL SHOW MULTIPLE PERF HOLES. THE WATER DEPTH WITHIN THE EASTERLY CELL IS AS LITTLE AS 14 INCHES, DUE TO SILT ACCUMULATIONS, AND AS MUCH AS 22 INCHES IN THE WESTERLY CELL. THERE ARE ISOLATED MISSING BOLTS ALONG THE BOTTOM EDGES OF BOTH PIPES. IN THE WEST PIPE, ONE OF BOLT HOLES APPEARS TO HAVE BEEN ELONGATED. THE VERY END OF THE WESTERLY CELL, ALONG THE NORTHWESTERLY CORNER WHICH ACTS AS A BANK RETENTION, SHOWS ABOUT FOUR LINEAR FEET OF HEAVY DETERIORATION TO THE UPPER PLATE EDGE. THIS AREA OF DETERIORATION APPEARS TO BE ABOUT 6.0 INCHES HIGH.

Photo # : PERF HOLES IN WEST PIPE.

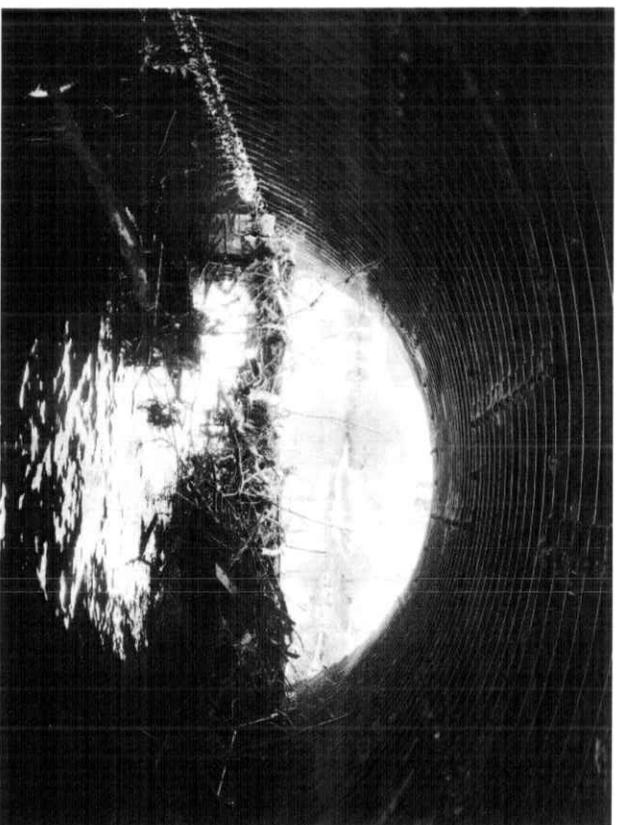
Photo # : LOOKING THRU EAST CELL.

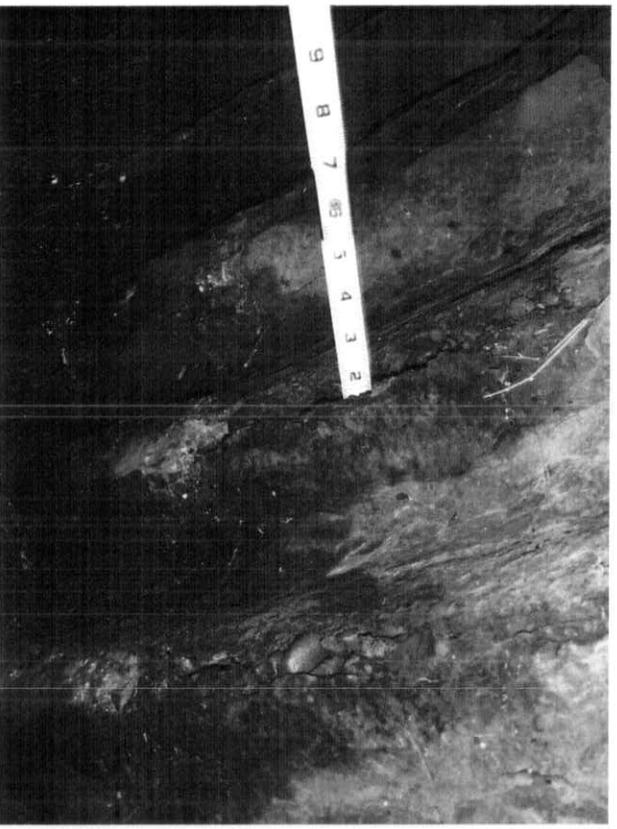
Photo # : PER HOLES IN EAST PIPE.

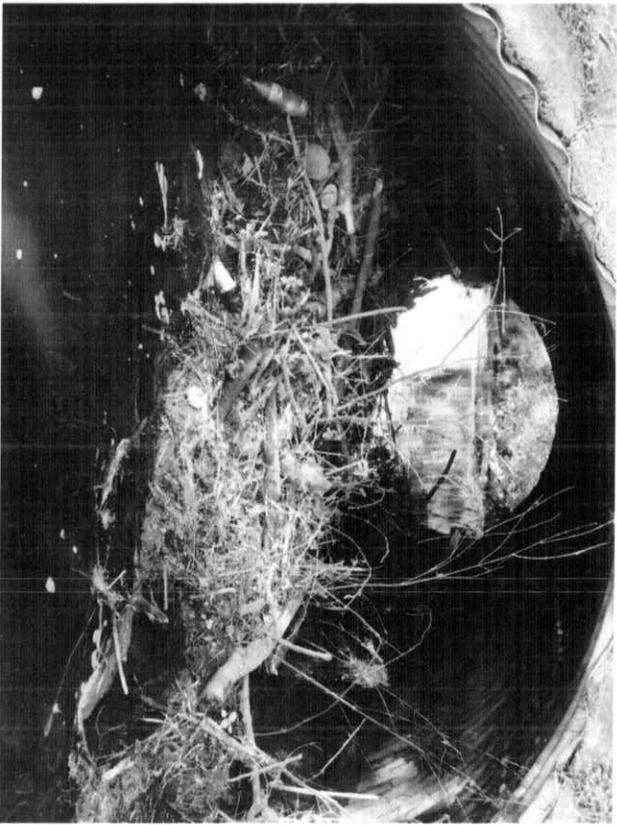
Photo # : VIEW OF DEBRIS IN EAST PIPE AT NORTH END.
