**Docket No. 217 – Development and Management Plan Inspection**

Northeast Utilities Service Company Certificate of Environmental Compatibility and Public Need for the construction of a 345-kV electric transmission line and reconstruction of an existing 115-kV electric transmission line between Connecticut Light and Power Company's Plumtree Substation in Bethel, through the towns of Redding, Weston, and Wilton, and to the Norwalk Substation in Norwalk, Connecticut.

**Date:** March 23-24, 2006

**Location:** 115 kV Underground Route

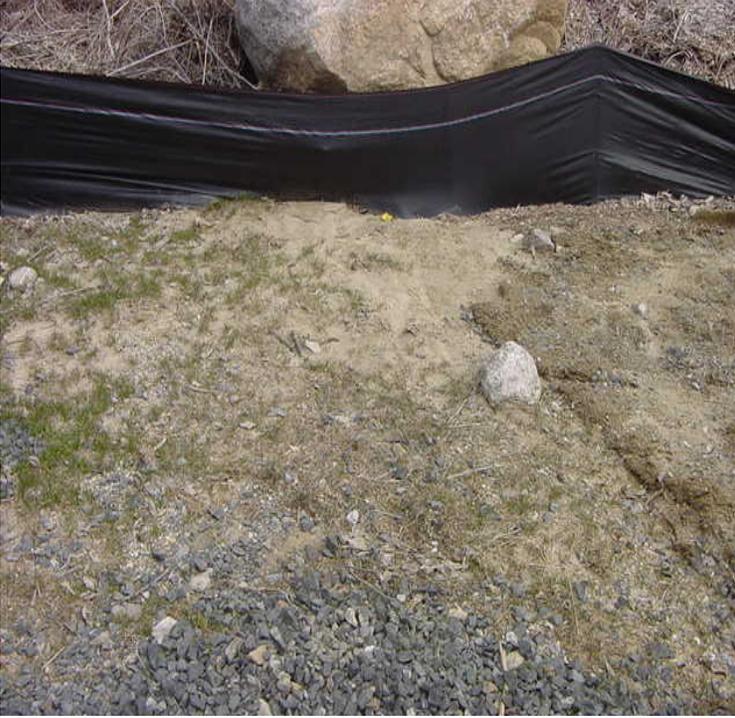
115kV (Bethel Ed and Sunset Hill Rd): Photo on the left shows where a small washout of sediment is getting under the silt fence near the north tower. Photo on the right shows the Sunset Hill storage area where a vehicle drove through. This is probably not project related. 3/24/06

Erosion and Sediment Controls <b>Bethel Education Park</b>	-Most fence is in good shape but a small washout was noted getting under the fence near the north tower. 3/24/06	-Continue to monitor to see if the recent fixes are the final repair necessary. Determine whether this minor washout is causing any issues. 3/24/06

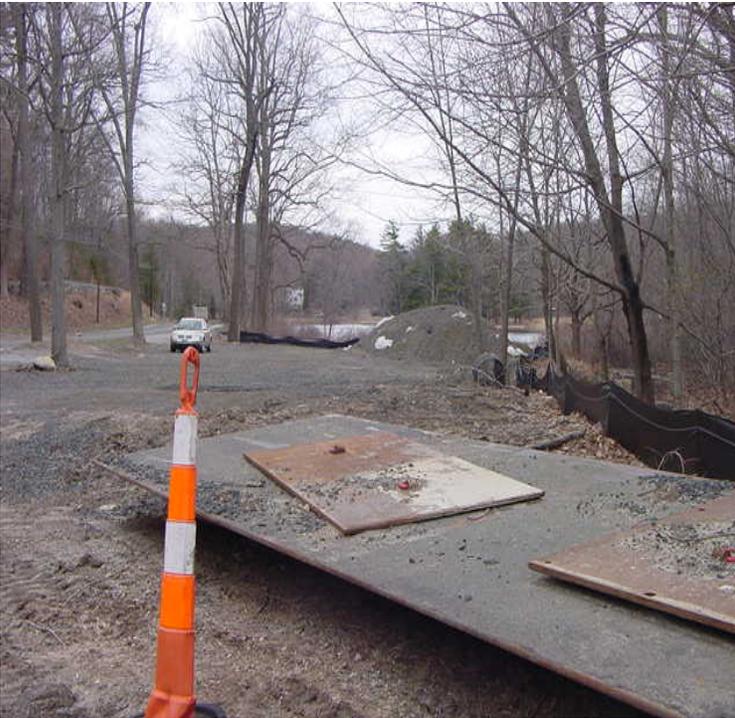
115kV (Putnam Park and Rt 107): Photo on the left shows an overview of Putnam Park storage area where controls remain in place. Photo on the right shows the storage area near the Redding CC. The area should be restored if it is no longer in use. 3/24/06
