Docket No. 217 – Development and Management Plan Inspection

Northeast Utilities Service Company Certificate of Environmental Compatibility and Public Need for the construction of a 345-kV electric transmission line and reconstruction of an existing 115-kV electric transmission line between Connecticut Light and Power Company's Plumtree Substation in Bethel, through the towns of Redding, Weston, and Wilton, and to the Norwalk Substation in Norwalk, Connecticut.

Date: September 29, 2005

Location: Overhead Line (Composite 345kV and 115kV Gallows Hill to Archers Lane)

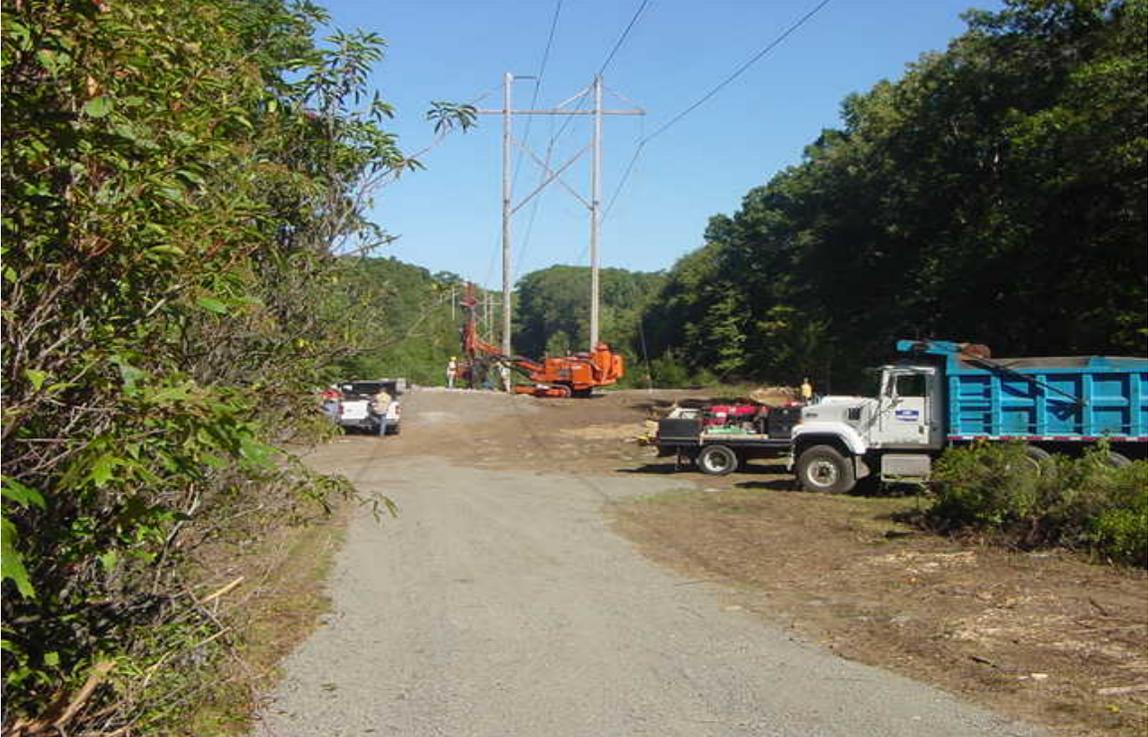
Overhead ROW: View of the drilling to set the foundation for the riser structure nearest to Gallows Hill Rd. (9/29/05)

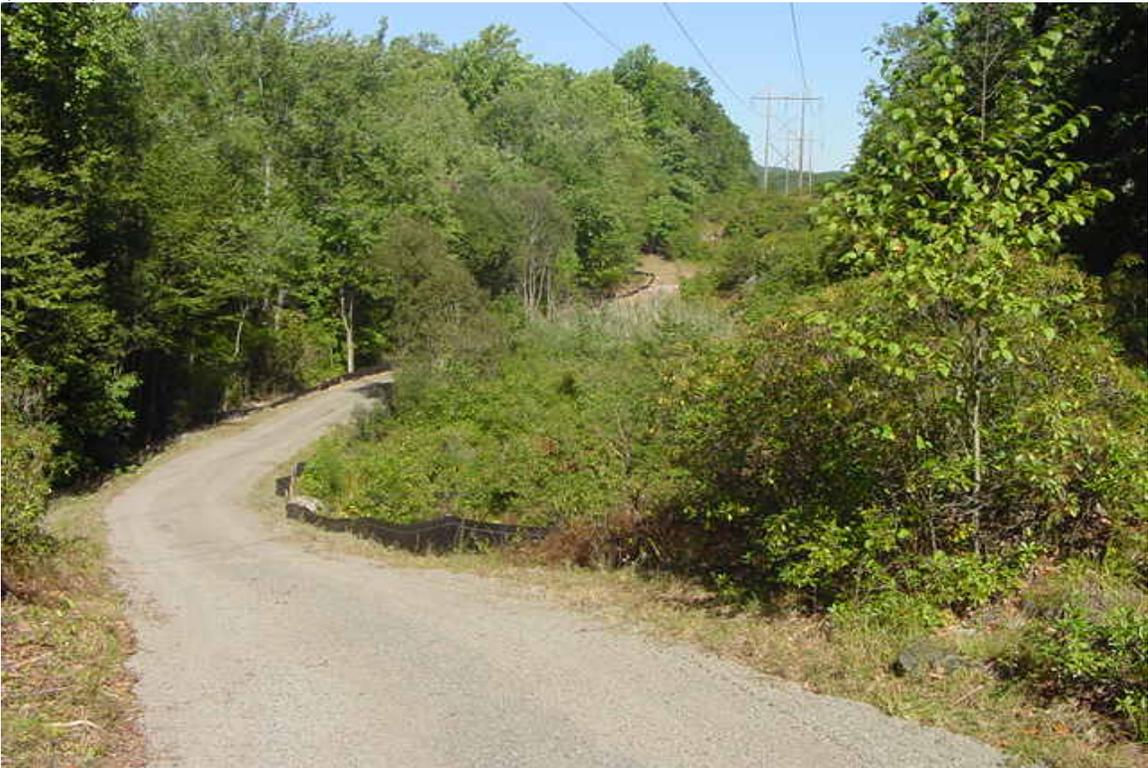
Overview of the access road within the ROW. The majority of this path and the access roads to the ROW have been placed with process stone/stone dust and are stable. (9/29/05)

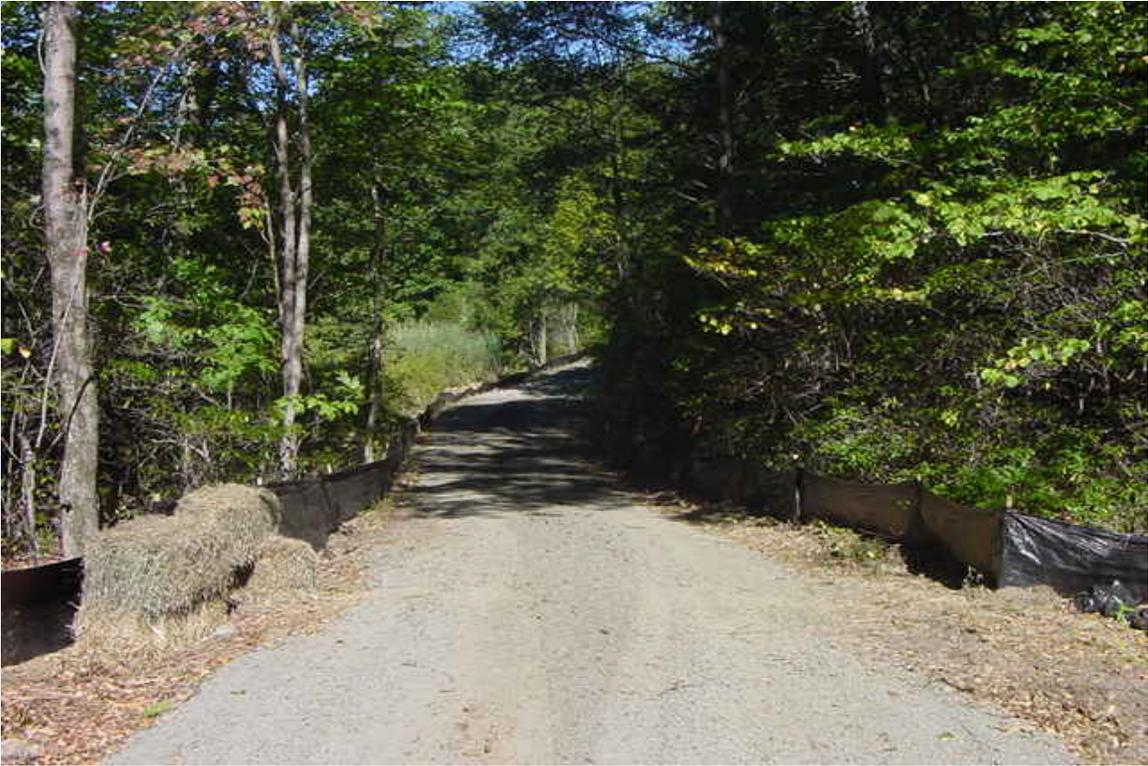
View of where the access path to the ROW intersects with the Archers Lane transition station site. Silt fence has been extended along the path. (9/29/05)

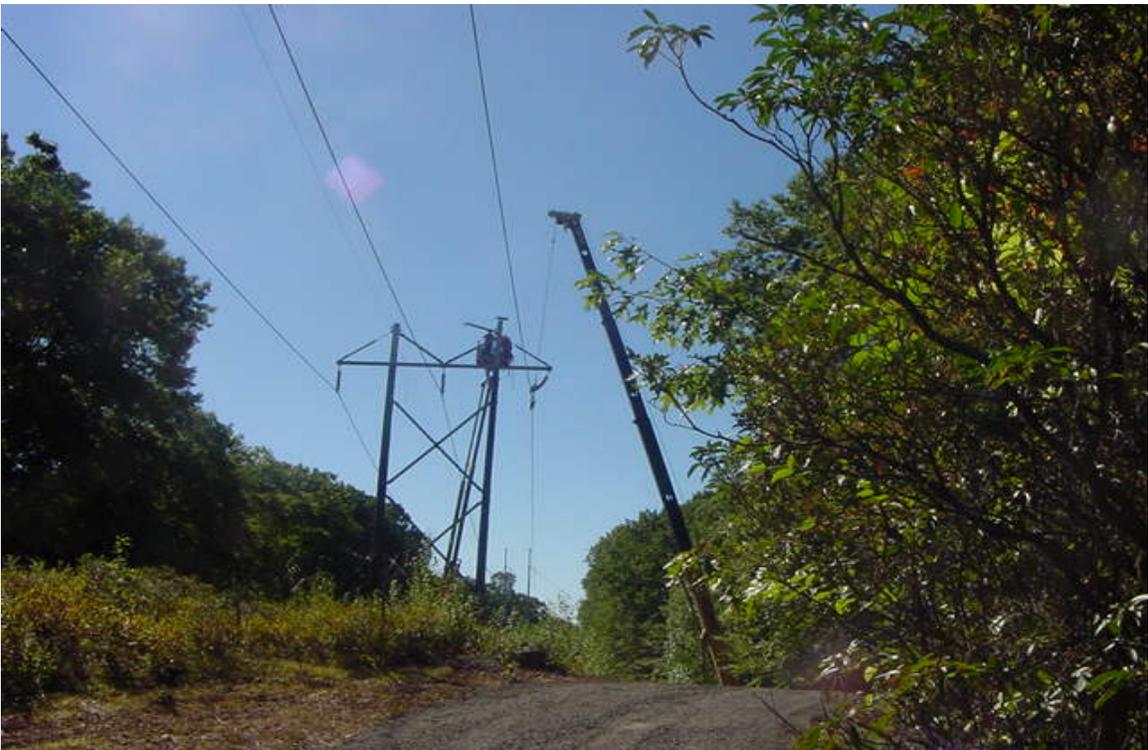
View of the CL&P crew removing the static line from the existing poles. (9/29/05)
